# Service Bulletin

Bulletin No.: 22-NA-015

**Subject:** Diagnostic Tips on GDS Graphing after Road-Test, for Shake and/or Shudder During Steady and/or Light Throttle Acceleration Between 25 and 50 MPH (40 and 80 KM/H) at Steady Speed, and Deceleration at approximately 15 MPH (24 KM/H).

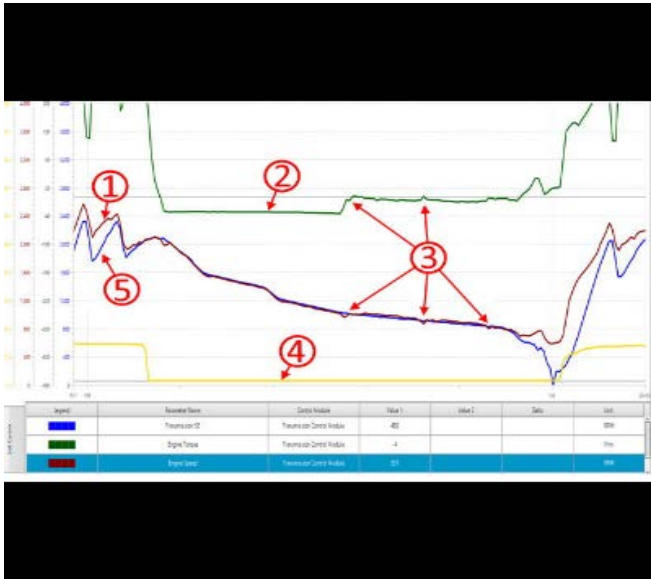
5975000

1. Engine Speed
2. Engine Torque
3. Vibration Felt after Engine Refuel, Should be in Reduced Firing Fraction
4. Pedal
5. Transmission Input Shaft Speed (ISS)

**Diagnostic Tip Closed Throttle Shudder – TSB**  
 21-NA-207: 2021 Silverado Sierra 5.3 (L84) 10 Speed (MQB) only.

The condition is only present at 0% throttle during a coast event at approximately 15 mph (24 km/h). Note the engine RPM and torque oscillations at engine refuel points.

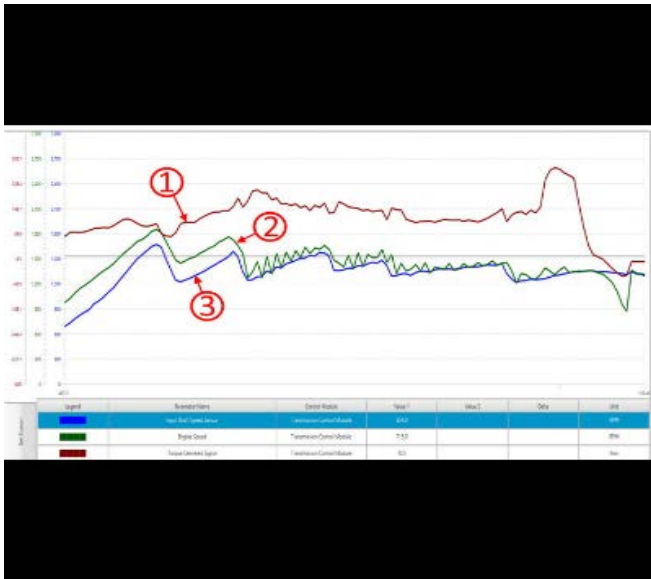
5975003

1. Torque
2. Engine Speed
3. Transmission ISS
  - The shudder condition is present both in Drive “D” or Manual “L9”.
  - Typically occurs at less than 15,000 miles (24,000 km)
  - Transmission ISS follows engine speed
  - Relatively consistent engine torque. <+/- 25 Nm

Engine torque remains relatively flat while engine speed rises and falls. The valve body should be replaced.

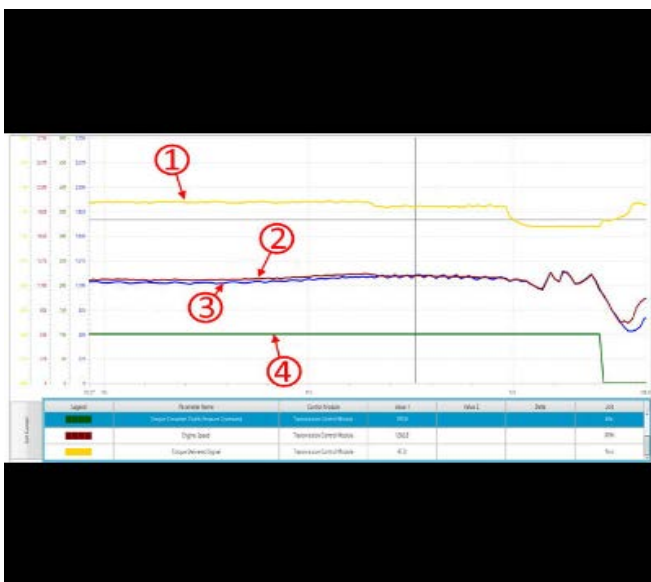
5975005

1. Torque
2. Engine Speed

3. Transmission ISS
4. TCC Pressure
  - Shudder condition is present in Drive “D” but NOT present in Manual “L9”
  - Throttle would typically be less than 10% and engine torque less than 100 Nm
  - TCC slip speed will be 0 or near 0
  - TCC pressure command will remain at 100 kPa

The valve body should be replaced.

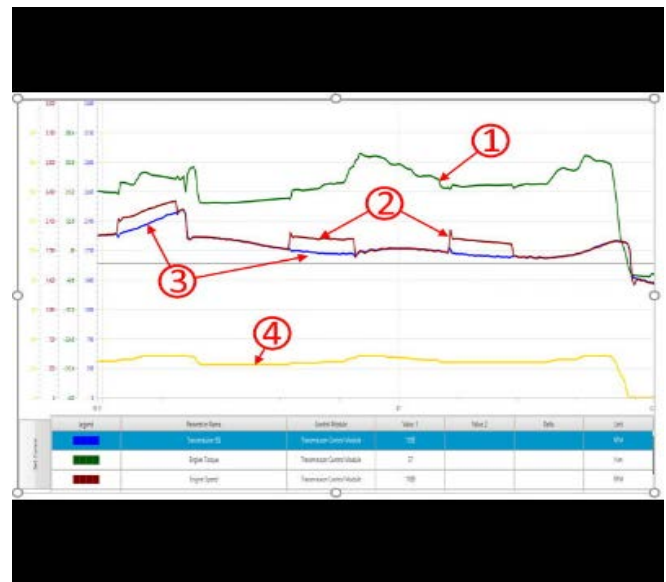
5975007

**Note:** This data should only be collected when driving the vehicle in manual 9th gear so dynamic fuel management is disabled.

**Note:** A slight vibration that can only be felt when dynamic fuel management is active should be deemed normal characteristic and engine and transmission components should not be replaced.

1. Torque
2. Engine Speed
3. Transmission ISS
4. Pedal
  - TCC pressure control is steady
  - TCC slip is elevated
  - Engine RPM will increase at the shudder point while Transmission ISS remains steady
  - Engine torque remains relatively steady during the shudder event
  - Throttle angle remains steady during the shudder event

**Note:** Warranty claim reviews indicate that when the torque converter is replaced for shudder that vehicle often returns for additional engine or transmission repairs. In most cases the torque converter is not the cause of the shudder.

The torque converter should be replaced.

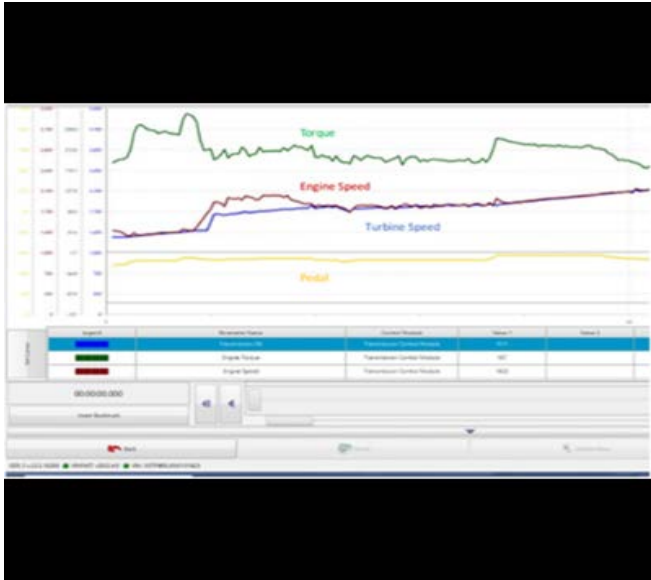
6124137

1. Torque
2. Engine Speed
3. Transmission ISS
4. TPS
  - Engine RPM is erratic
  - Throttle is fairly steady/constant
  - Magnitude of RPM and TPS signal is relatively small
  - Engine RPM will not be in sinewave pattern. The issue is possibly related to one or more fuel injector.
