MAS003732 RU 23-49

Rapid Update 654

Granturismo – Door-fender gap & flush check

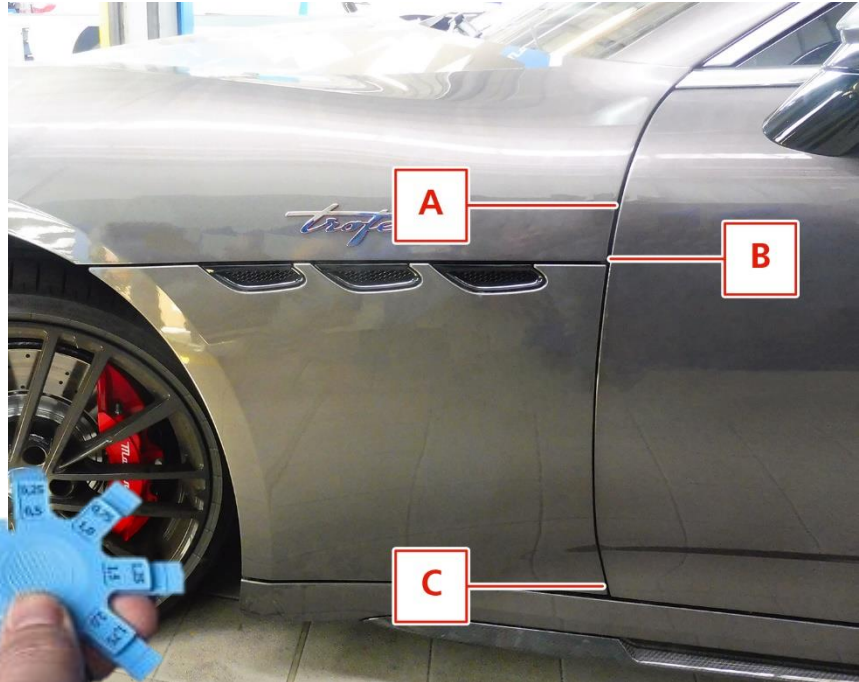
Measuring points
Following instruction on page 3

Certain Maserati GranTurismo (189) MY24 are involved in a Rapid Update to carry out a door fitment inspection procedure due to an interference with the fender.

This action is necessary because, on a limited number of vehicles, the gap and flush between the door and the fender could be incorrect.

Use a suitable gauge, check the relative positions of the hood, fender, and door.

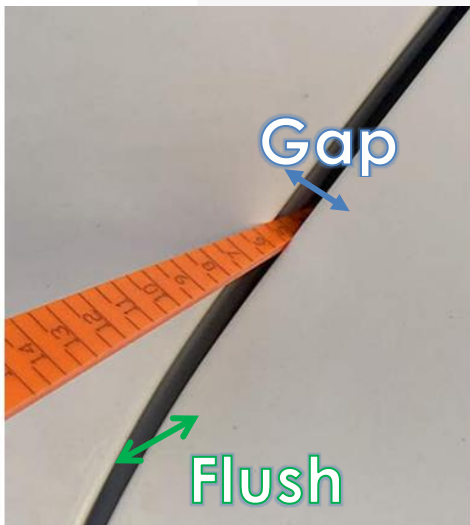
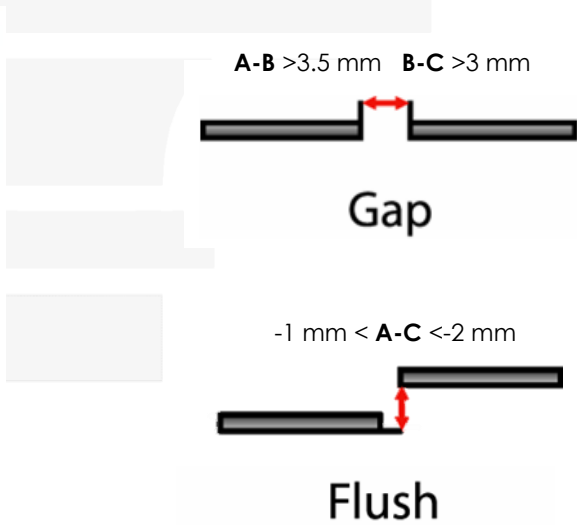
GAP means the span between the two profiles in the longitudinal direction, while the **FLUSH** is the distance between the profiles in the transverse direction.

- The **GAP** (distance in the longitudinal direction) must be > 3.5 mm
- The **FLUSH** (distance in transverse direction) must be between -1 mm and -2 mm

- The **GAP** must be > 3 mm
- The **FLUSH** must be between -1 mm and -2 mm

2. If the measurements are correct, the car is **OK** and no further adjustments need to be made.
3. If one or more measurements do not fall within the range described, continue with the adjustment based on the following parameters.
4. If the **GAP** between **A and B** is more than 3.5 mm, proceed with the **adjustment of the front hood** on the X-axis.
5. If the **FLUSH** between **A and B** is **not** between -1mm and -2mm, proceed with the Y-axis **fender adjustment**.
6. If the **GAP** between **B and C** is more than 3 mm, proceed with the adjustment **of the fender** on the X-axis.
7. If the **FLUSH** between **B and C** is **not between -1 mm and -2 mm**, proceed with Y-axis **fender** adjustment. Follow the correct procedure reported in the bulletin.
