#### FRESH TANK SENSOR / GREY TANK SENSOR RESET TOFINO

#### HOW TO ACCESS FRESH TANK SENSOR / GREY TANK SENSOR TOFINO AND REPLACE SENSOR

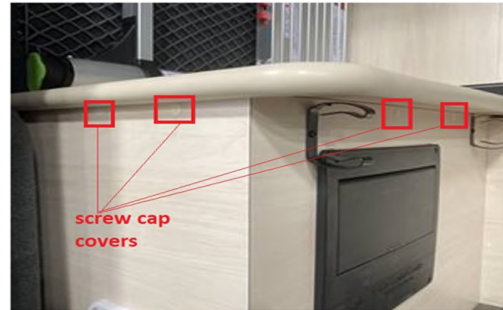
If you need to access tank sensors, it will be at the back driver side rear (see picture below) There will be screw cap covers just under the top panel. You need to remove the table leg for you to see it. There will be screw cap covers on the other side as well. Once all screws are removed, you can pull up that partition. It will be on the inside right side.

You will see 2 sensors with wires (1 for each tank). Top sensor if for fresh tank and bottom sensor is for grey tank.

Remove the driver's rear ledge and you will see rear of tank with the spider tank level sensor inboard of the wheel well. This is easy to get at and change. The wood panel may need to be trimmed a bit to be able to pull out sensor. Tank stays where it is.
