REFERENCE:	TSB: 08-201-23 GROUP 08 - Electrical	Date:	August 22, 2023	REVISION:	-
VEHICLES AFFECTED:	2022 - 2023 (DS) RAM 1500 Pickup This bulletin applies to vehicles built on and before June 05, 2023 (MDH 0605XX) equipped with a Global Telematics Box Module (Sales Code RDG).			MARKET APPLICABILITY:	
				<input checked="" type="checkbox"/> NA	<input type="checkbox"/> MEA
				<input type="checkbox"/> SA	<input type="checkbox"/> IAP
				<input type="checkbox"/> EE	<input type="checkbox"/> CH
CUSTOMER SYMPTOM:	<p>The customer may experience the one or more of the following:</p> <ul style="list-style-type: none"> • Uconnect Box Message at Startup. • Uconnect Box Error Or Requires Service Message. • Uconnect Mobile App trunk status showing as closed when trunk is open. • Diagnostic Trouble Codes (DTCs) for Electronic Control Modules (ECUs) won't be shown to customer through the Vehicle Health alert (Mobile App or email).

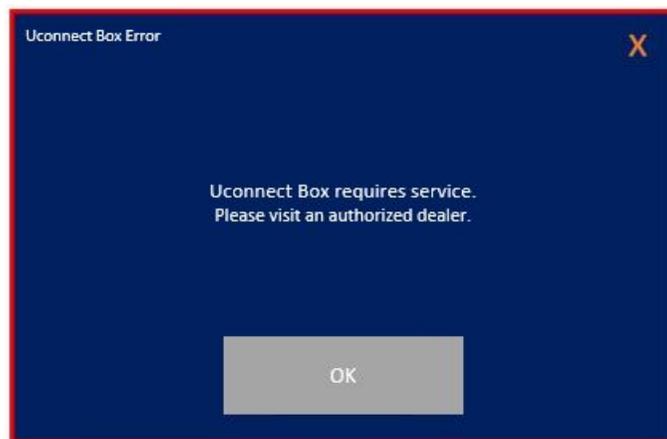
Fig. 1
Uconnect Box Error Message

CAUSE:	TBM Software

Message display on the radio screen, “Uconnect Box requires service. Please visit an authorized dealer.” (Fig. 1) , with no active or stored DTCs set by the TBM.

The TBM software will be updated from 5.25 to 5.39.1.

1. Reprogram the TBM with the latest software. Detailed instructions for flashing control modules using the wiTECH Diagnostic Application are available by selecting the application's "HELP" tab.
2. Clear all DTCs that may have been set in any module due to reprogramming. The wiTECH application will automatically present all DTCs after the flash and allow them to be cleared.
