### **Service Bulletin**

Bulletin No.: 23-NA-163

Subject: No Crank, No Start, Quick Start/Stall, No FOB Detected, Key FOBs Inoperative, B3924 00, B3925 00, B3926 00, B3927 00, B3928 00 Set

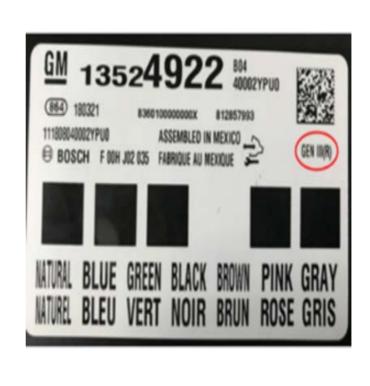
6430397

Correction	This procedure ONLY applies to the GEN3R BCM		
	GEN3R BCMs can be identified by either the label on the module or looking up the BMPN part number information in GDS2.

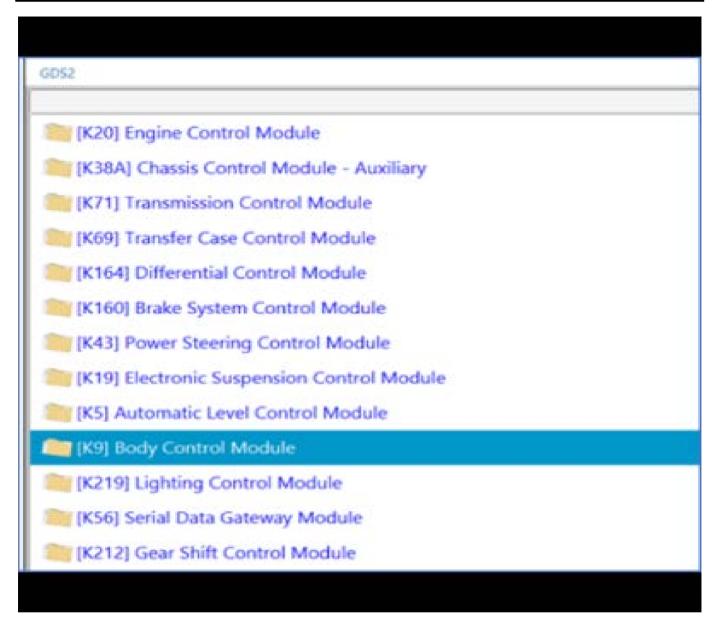
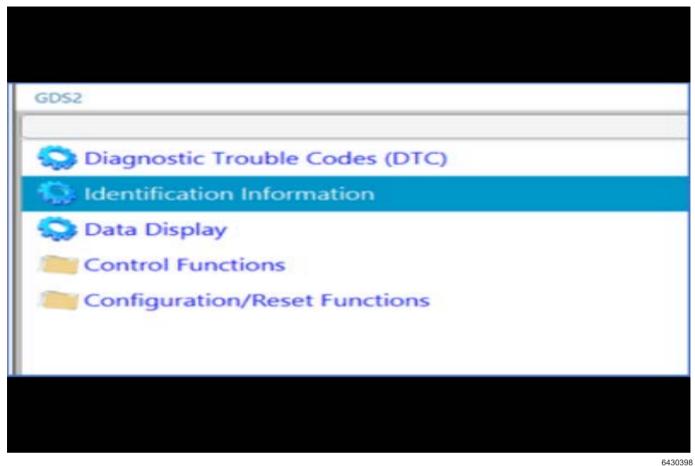
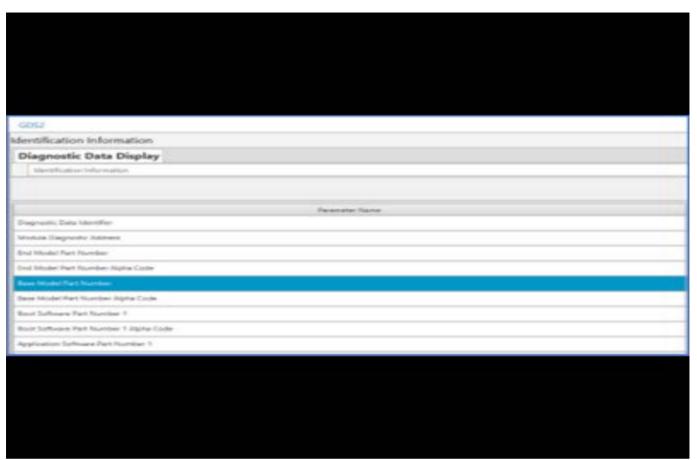
Verify you have a GEN3R BCM Base Model Part Number. Only GEN3R BCMS are eligible for this bulletin. Navigate to GDS2 > Module Diagnostics > [K9] Body Control Module > Identification Information > Identification Information.
