Service Bulletin

Bulletin No.: 23-NA-165

Subject: Vehicle Will Not Lock and Unlock (Loss of Active Functions) Crank or Start (Loss of Passive Functions) with DTC P0513 Set

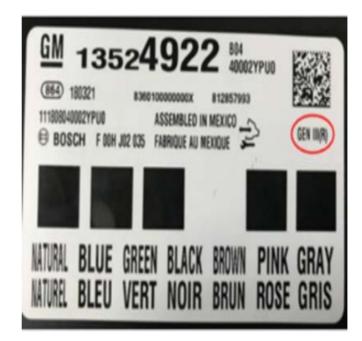
GEN3R BCMs can be identified by either the label on the module or looking up the BMPN part number information in GDS2.

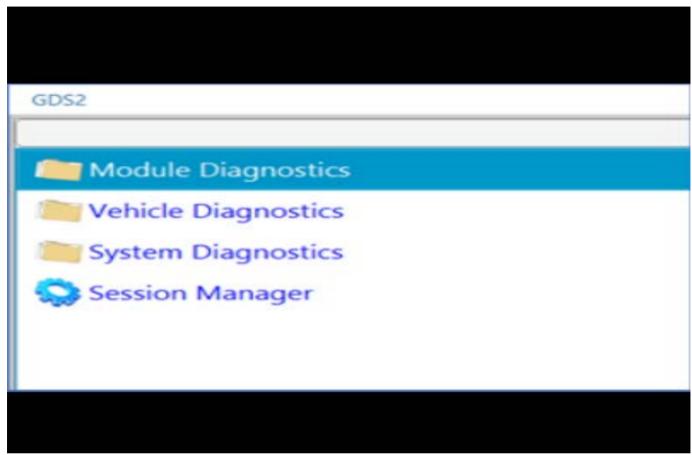
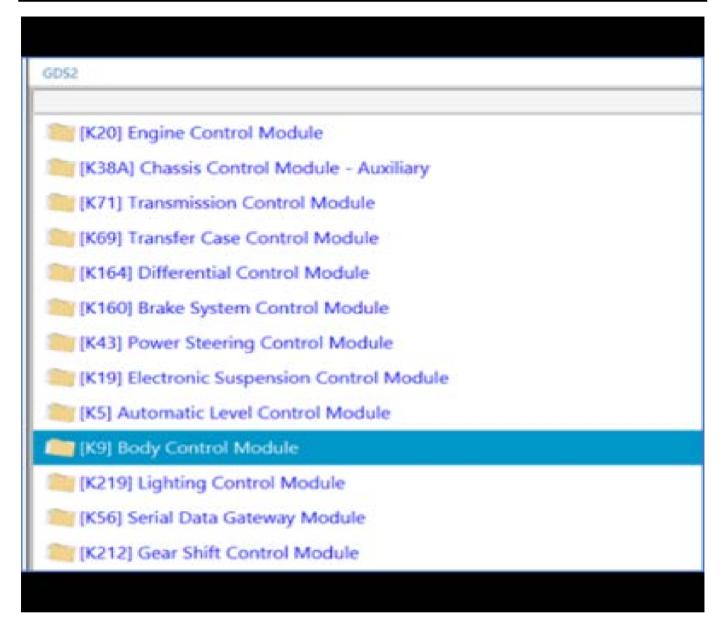
Verify you have a GEN3R BCM Base Model Part Number. Only GEN3R BCMS are eligible for this bulletin. Navigate to GDS2 > Module Diagnostics > [K9] Body Control Module > Identification Information > Identification Information.
