**October 6, 2023**

Version 2

**Warranty Extension: 2017–19 Multi Model 6AT Torque Converter – DTC P0741 Stored****Supersedes 23-078, dated August 31, 2023, to update the information highlighted in yellow.****AFFECTED VEHICLES**

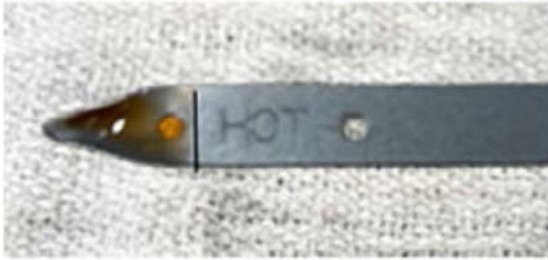
#### COLD CHECK

- Overfilled transmission level can cause an overheat condition.
- Check the ATF level when the fluid temperature is greater than or equal to **80°C (176°F)**.
- If the fluid level is checked at a cooler temperature, it will read low or on the bottom dot of the dipstick.
- If the transmission fluid is filled to the top dot when cold, the transmission will be overfilled, increasing foaming and contributing to the overheating problem.

2. Check ATF level.
