ADDRESSEES	: Owners and operators of vehicles mentioned under “Application” ABC Customer Care and Parts Source
VEHICLE TYPE	: CX45 MY2023
CONFIGURATION GROUP	: 2.46 Traction engine – Accessory drive
BULLETIN TYPE	: Field change program
DATE	: October 16th, 2023
SUBJECT	: Inspection of automatic belt tensioner base plate fasteners
CONDITIONS	: Refer to chapter "Warranty" further on in this bulletin.

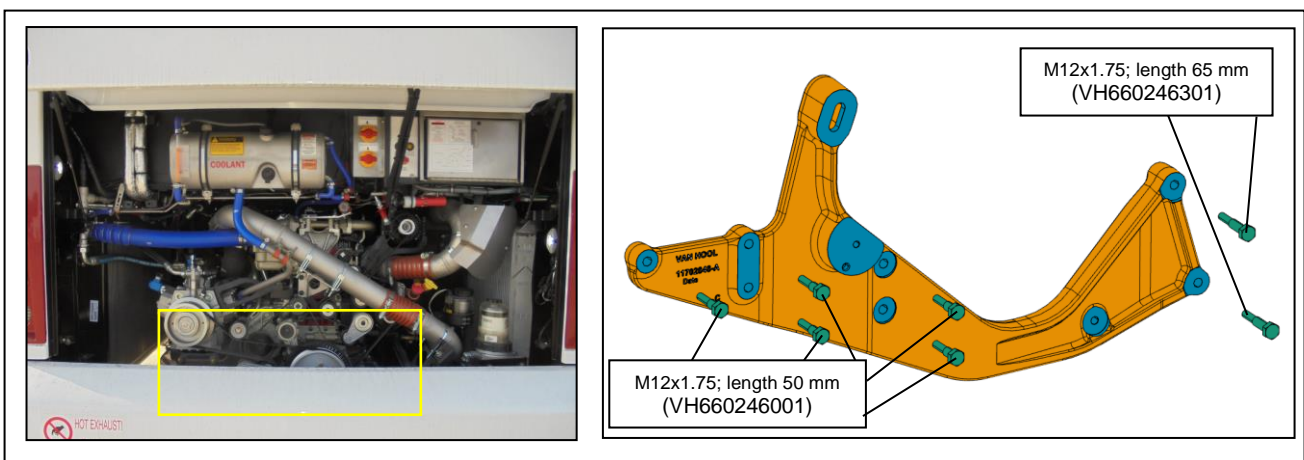
Van Hool has determined that some of the seven fasteners securing the automatic belt tensioner base plate are subject to slackening. Tests have shown that these fasteners must be installed with Loctite 243 and tightened to a torque of 90 ± 10 Nm (65 ± 7 ft.lbf).

Figure 1: Location of the fasteners securing the automatic belt tensioner base plate

To address this issue, Van Hool is conducting a field change program whereby the seven fasteners must be removed and checked one by one for length and thread pitch (1.75 mm). What to do next is explained in this service bulletin.

Step	Action
1	Open the engine compartment rear access door.
2	Remove one of the seven affected fasteners (refer to figure 1).
3	Identify the length and thread pitch of the fastener (refer to figure 1). <ul style="list-style-type: none">• If length and thread pitch are okay: clean the thread of the fastener removed. Apply Loctite 243 on the thread and re-install the fastener with a torque of 90 ± 10 Nm (65 ± 7 ft.lbf).• If the thread pitch is okay, but the length is not: take a fastener with the proper length. Clean the thread of the fastener. Apply Loctite 243 on the thread and install the fastener with a torque of 90 ± 10 Nm (65 ± 7 ft.lbf).• If the length is okay, but the thread pitch is not: temporary re-install the 1.5 mm thread pitch fastener with a torque of 90 ± 10 Nm (65 ± 7 ft.lbf) and contact ABC to determine the next step.
4	Repeat steps 2 and 3 for the six other affected fasteners.
