# Service Bulletin

Bulletin No.: 21-NA-228

Date: October, 2023

**Subject: Full Size Trucks Idle Time-out Disable**

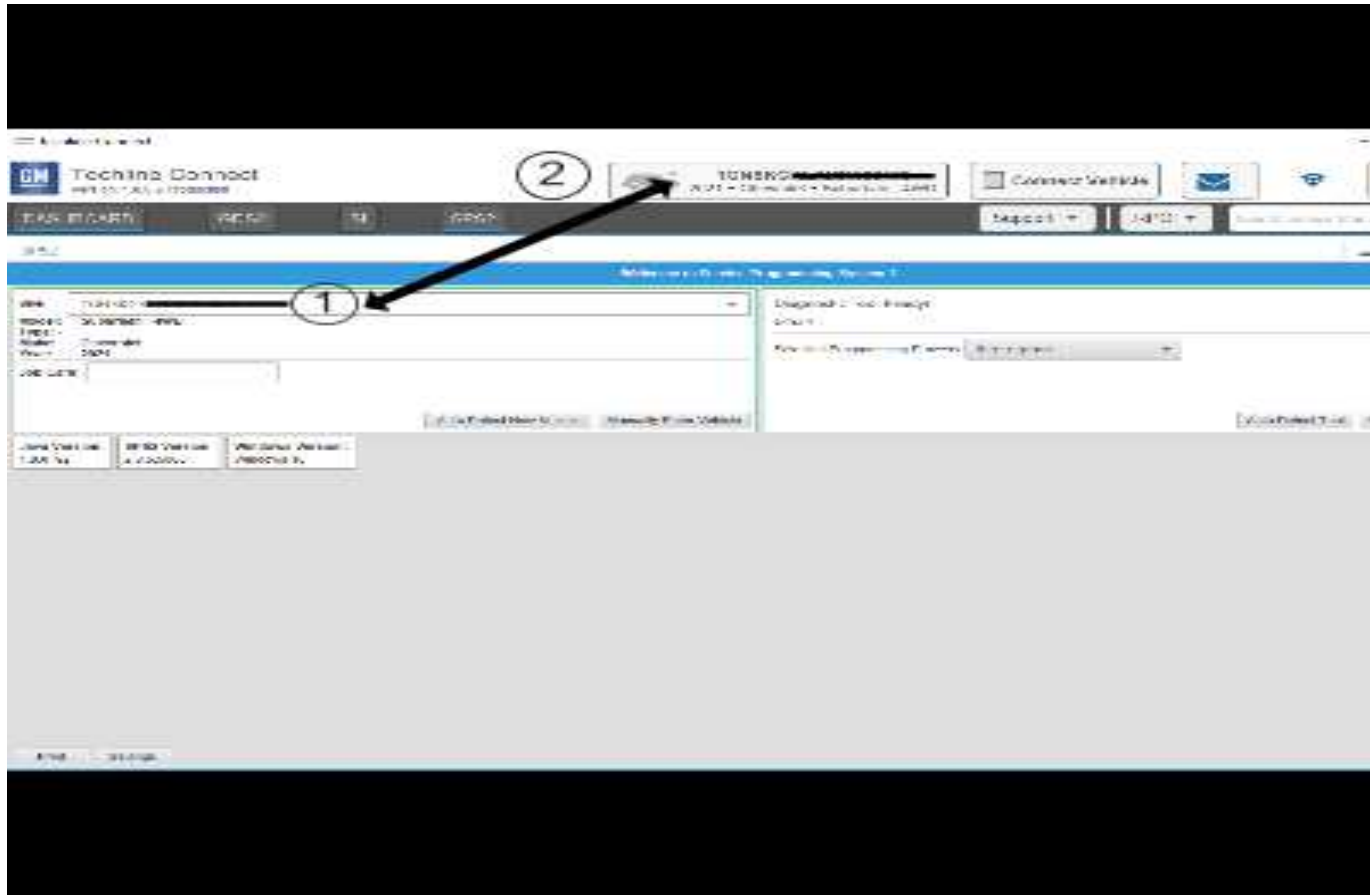
5743643

**Caution:** Be sure the VIN selected in the drop down menu (1) is the same as the vehicle connected (2) before beginning programming.

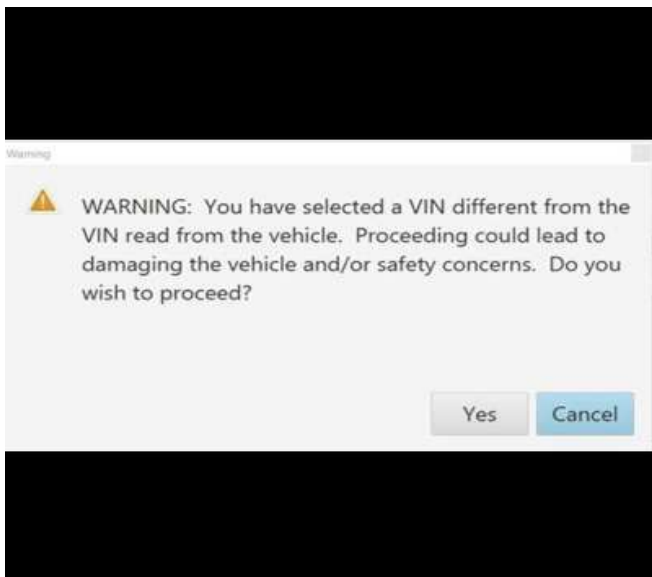
5877000

**Important:** If the vehicle VIN DOES NOT match, the message below will be shown

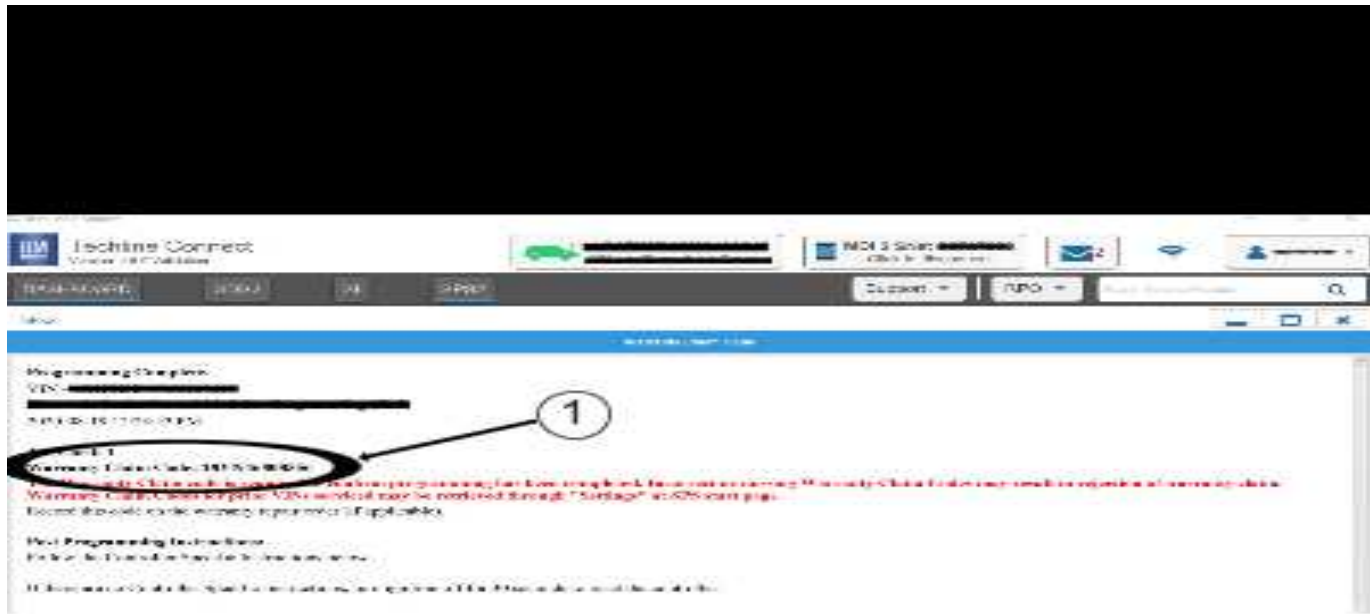
5644478

**Important:** To avoid warranty transaction rejections, you **MUST** record the warranty claim code provided on the Warranty Claim Code (WCC) screen shown above on the job card. Refer to callout 1 above for the location of the WCC on the screen.

2. Record SPS Warranty Claim Code on job card for warranty transaction submission.
