Service Bulletin

Bulletin No.: 21-NA-290

Subject: Wrinkle or Bubble in Stripe or Hood Wrap forming Around Outer Edges of Hood Air Scoop

Brand:	Model:	Model Year:		VIN:		Engine:	Transmission:
		from	to	from	to		
Chevrolet	Camaro	2019	2024	—	—	—	—

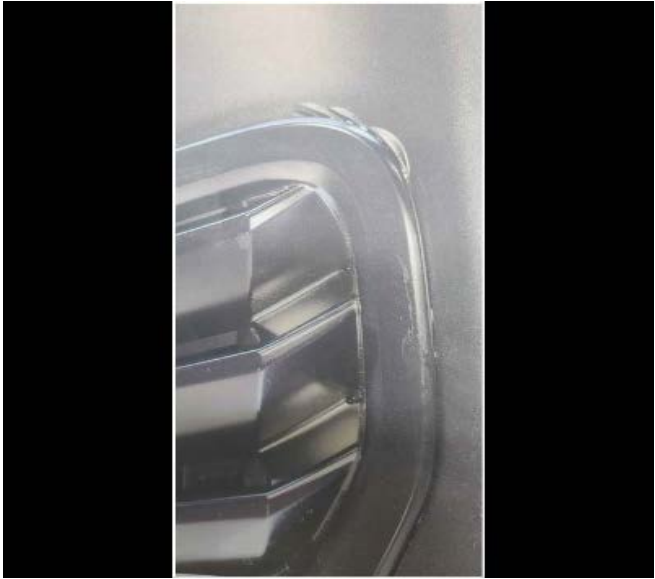
</div> <p style="text-align: right; font-size: small;">5937945</p> <p>Some customers may comment on a wrinkle or bubble in the stripe or hood wrap forming around the outer edges of the hood air scoop.</p>
Cause	This condition may be caused by edges on the bottom of the hood air scoop pressing deep into the stripe or hood wrap, causing air pockets to form over time.
Correction	If you encounter a vehicle with the above concern, refer to the Service Procedure below.
