SIB 17 01 00

Coolant Return Hose Rubbing

540iA	540iATouring	540i	740iA
740iLA

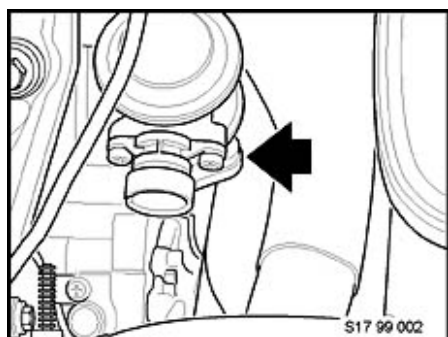
2. Visually inspect the lower radiator coolant return hose for signs of contact with the secondary air system check valve flange gasket.(Arrow shows contact area)
3. File off the protruding gasket edge.

The lower radiator coolant return hose may come in contact with the secondary air system check valve flange gasket when the engine coolant is at operating temperature due to coolant system pressure and expansion of the hose.

Note: Cover up drive belts and pulleys using a clean shop rag before filing to prevent metal filings from falling on them.

File off the protruding portion of the secondary air system check valve flange gasket and install a protective sleeve part number 11 53 7 505 832 on the hose in the contact area.
