SIB 52 08 22

HEADREST IS UNCOMFORTABLE FOR SOME OCCUPANTS

E-Series	Model Description	Production Date
i20	iX xDrive50/M60	Vehicles produced from start of production up to July 1, 2023

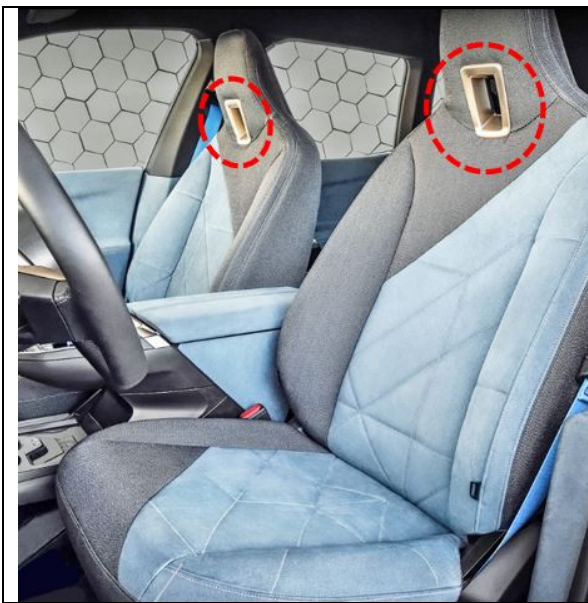
The decorative hard plastic piece, centered in the front seat's headrest (circled area), may contact a person's head when they are between 4' 10" and 5' 6" in height.

Design element of the seat.

In the case of customer concern, for applicable vehicles produced prior to July 1, 2023, there is a push-in cushion insert available to plug up the square hole in the front seat headrest(s) that provides additional support.
