SIB 61 23 23

**SERVICE ACTION: REPLACING THE CELL MODULE OF THE HIGH-VOLTAGE BATTERY**

E-Series	Model Description	Production Date
G26 BEV	i4 Gran Coupe	August 10, 2022 – September 2, 2022

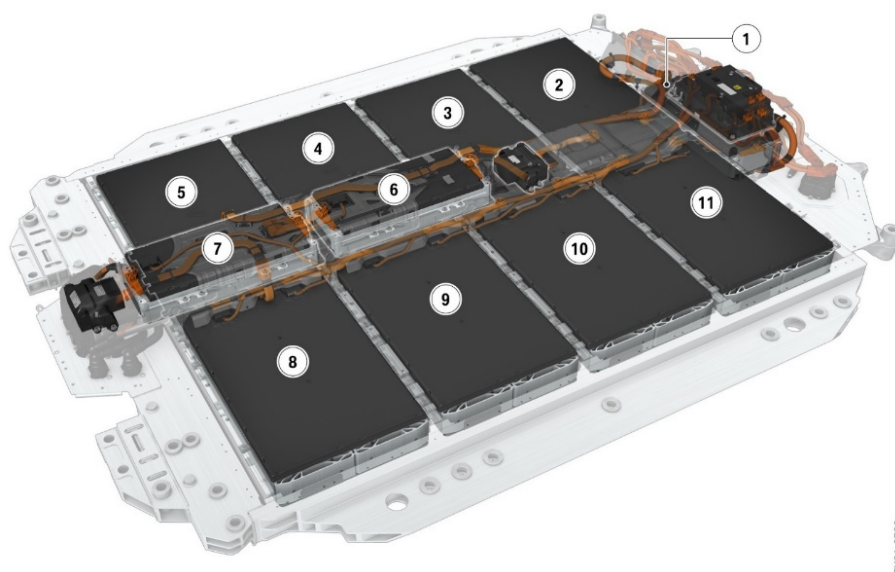
TH21-0786

G26 BEV SE27 HB Battery module locations shown below-

3. Replace the defective high-voltage cell modules using repair instructions **61 27 703** to **61 27 877** depending on the affected cell module location.
