SIB 63 12 23

## EXTERIOR LIGHTING SWITCH FAULT CODE STORED IN THE BCP (BASIC CENTRAL PLATFORM)

E-Series	Model Description
G60	5 Series Sedan

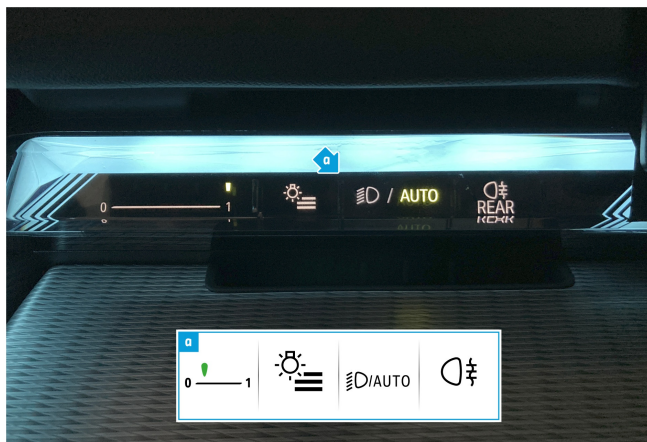
Upon performing a vehicle read out, fault code **(CD0D16- Control unit light (BEL) (LIN): Wrong variant installed)** is stored in the BCP (Basic Central Platform).

**Note: Functionality of the exterior lights and switch is fully operational when fault code is present.**

A software error in the BCP (Basic Central Platform).

Program the vehicle using ISTA version **4.44.1x** to **(G070-23-11-520)** or higher. This ISTA version is expected to be released late October 2023, pending verification.
