TECHNICAL SERVICE BULLETIN

Technical Service Bulletin: 37-1692
EXPIRATION DATE: May 31, 2024

TECHNICAL SERVICE BULLETIN 37-1692 REMEDY INSTRUCTIONS

Make(s): SURVEYOR Model(s): SVTG268FKBS & SVTG305RLBS Model Year(s): 2024	Repair Code: SB-499-03-00-004426 Allotted Time: 1.00 HRS. Inspection Code: N/A Allotted Time: N/A
	Concern: The 42" X 22" Egress window(s) may leak.	Photo(s) Required: YES, POST REMEDY Prior Authorization Required: YES Part(s) Number: N/A Part(s) Return: N/A

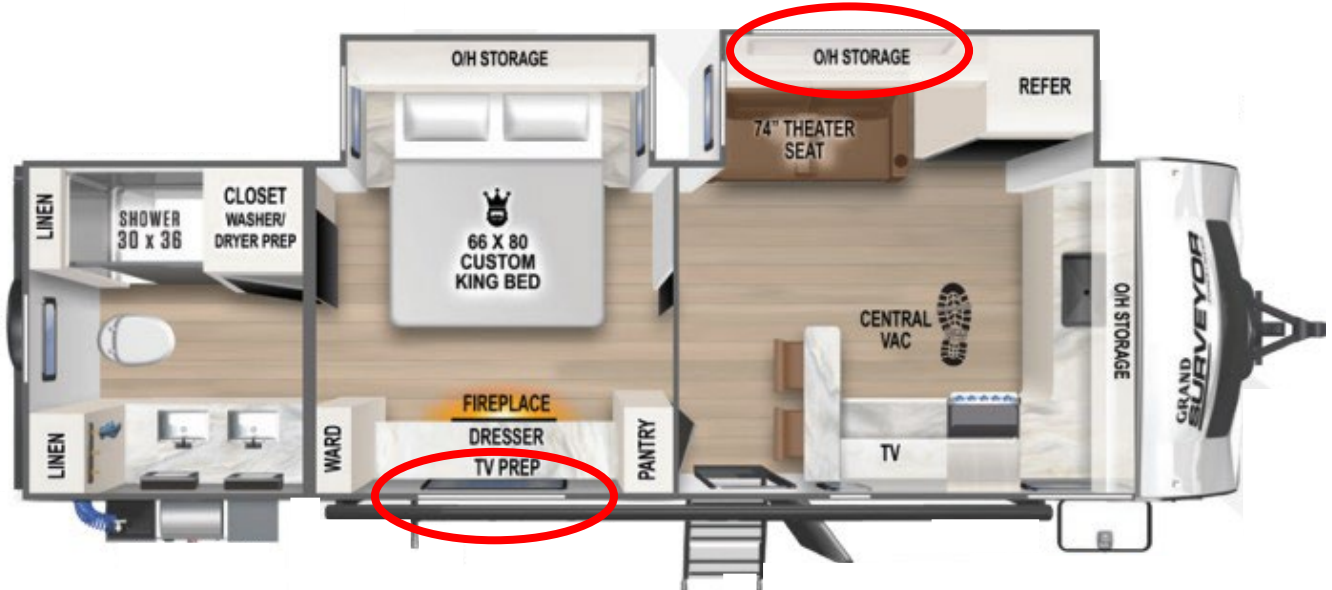
FIGURE 1

- SVTG268FKBS: 2, ONE ABOVE THE FIREPLACE AND ONE ABOVE THE THEATER SEATING CIRCLED IN RED (FIGURE 1);
- SVTG305RLBS: 1, ABOVE THE BED IN THE SLIDE MAIN WALL CIRCLED IN RED (FIGURE 2)
