SIB 52 09 20

2023-10-20

**HEAD RESTRAINT AND/OR BACKREST OF 3RD ROW SEATS CANNOT BE FOLDED DOWN**This Service Information Bulletin (Revision 6) replaces SI B52 09 20 **dated August 2023**.**What's New:**

E-Series	Model Description
G07	X7 Sports Activity Vehicle

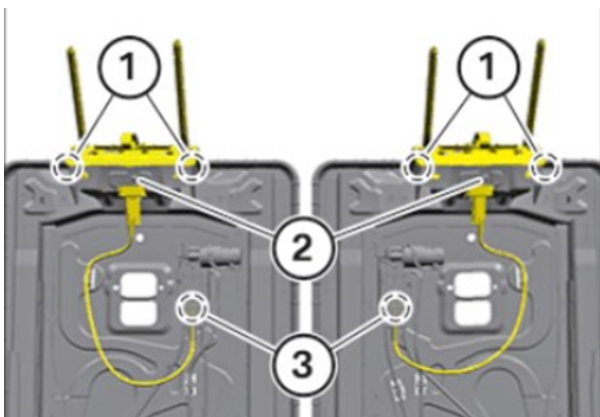
Can the head restraint be manually unlocked using the release loop beneath the headrest (see picture) and thus folded down?

**YES** = Head restraint mechanism is faulty. Determine root cause of Bowden cable not moving (see steps below). If the cable is moving fully but the headrest is not folding, then replace the folding module of the head restraint (#2 in picture).

See REP 52 30 118 Remove and install/replace folding module of left or right head restraint

**NOTE:** The head restraint cannot be removed without destroying the covering material. **A new cover (leather) will be required to perform this repair.**

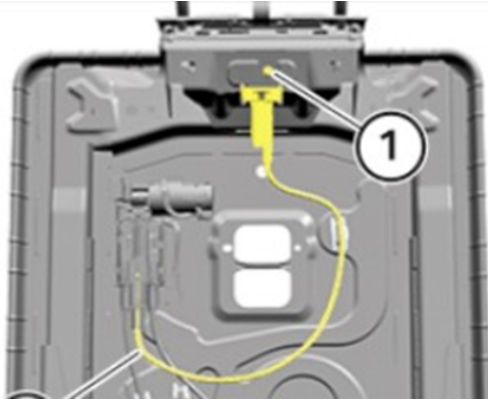
**NO** = Check if the Bowden cable is correctly mounted and properly routed.

If the Bowden cable is mounted properly and cable correctly routed and the electric motor moving the common housing pulls all 3 Bowden cables equally but the headrest Bowden cable does not travel far enough, replace the Bowden cable for the headrest (shown in yellow in picture).

See REP 52 30 253 Replace Bowden cable for left or right head restraint (Bowden cable unlocking device for head restraint).

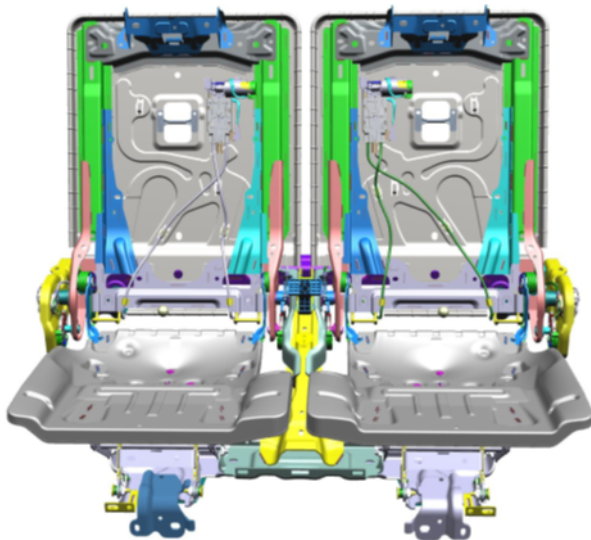
### Cable routing FROM February 2023 shown.

**NOTE:** A Bowden cable routing change was made in the third seat row backrest. This change was implemented starting in February 2023 production.

Replacement parts are all the new shortened design cable and require a new routing to install in vehicles produced prior to February 2023.

See Service Bulletin **B52 14 23**

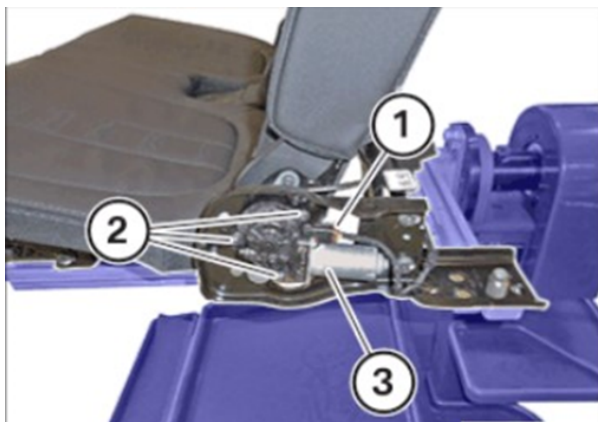
Check if the latch (the fastener on the left or right side) of the third row of seats is open or closed? (this is the hook/pin shown in green in picture)

If the head restraint stays in the seat position, the latch is closed.

If the head restraint falls into the folded position again, the latch is open.

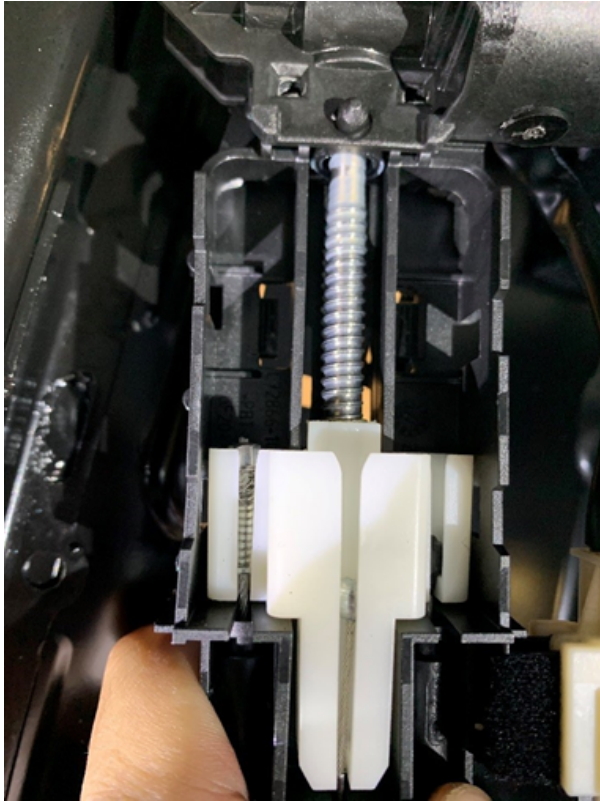
**NOTE:** If the seat was moved manually with excessive force, it may cause damage to the internal gear of this actuator. The motor may spin but the seat backrest may not move. In this case replacement of the drivetrain for backrest tilt adjustment is needed and the seat frame would not need replacement. There may be noise from the motor if it is internally damaged. To check the gear mechanism, the motor can be removed for inspection.

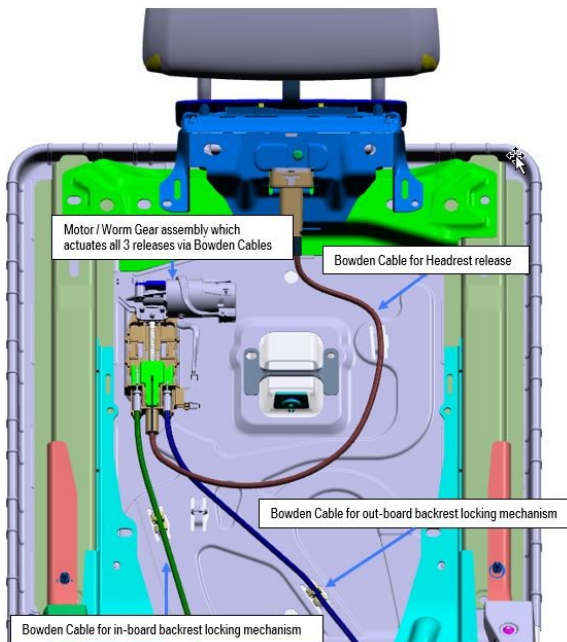
**NOTE:** The 3 Bowden cables are housed in a common housing that moves along a worm gear assembly.

When the electric motor activates, it spins the worm gear to pull up on the housing so that all 3 cables move simultaneously.

One of the cables controls the head restraint folding. Once pulled, the headrest will release and pivot downwards. **Raising the headrest back into the upright position must be done by pushing up on it by hand.**

(The other two cables control the latch release at the seat pivot to enable the seat to fold.)

Is the drivetrain for the backrest release (actuator) broken?

**YES** = Replace only the drivetrain for backrest release (actuator).

See REP 67 31 645 Remove and install/replace drivetrain for backrest release of third-row seating (left or right) (according to vehicle diagnosis)

**NO** = Replace BOTH the Bowden cable(s) and drivetrain for backrest release (actuator).

See appropriate repair instruction:  
REP 52 30 256 Replace Bowden cable for left or right rear seat backrest (Bowden cable for outer backrest release)

REP 52 30 255 Replace Bowden cable for left or right rear seat backrest (Bowden cable for inner backrest release)

REP 67 31 645 Remove and install/replace drivetrain for backrest release of third-row seating (left or right) (according to vehicle diagnosis)
