Service Bulletin

Bulletin No.: 22-NA-095

Subject: Front Brake Squeal Noise Heard During Light Brake Pedal Application

Brand:	Model:	Model Year:		Date Breakpoint		Engine:	Transmission:
		from	to	from	to		
Buick	Encore GX	2020	2022	March 21, 2020	February 14, 2022	All	All
Chevrolet	Trailblazer (VIN M)	2021	2022

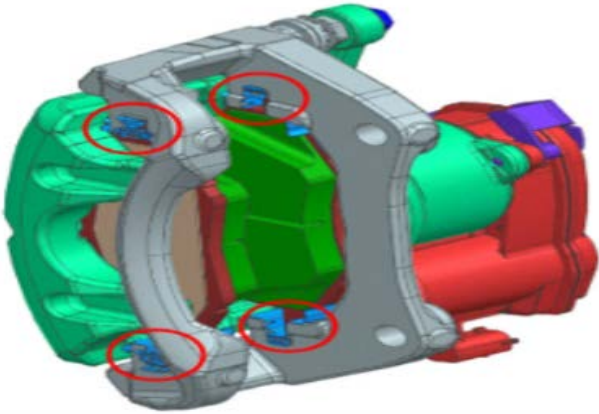
6077243

Note: There are 4 Pad abutments per caliper.

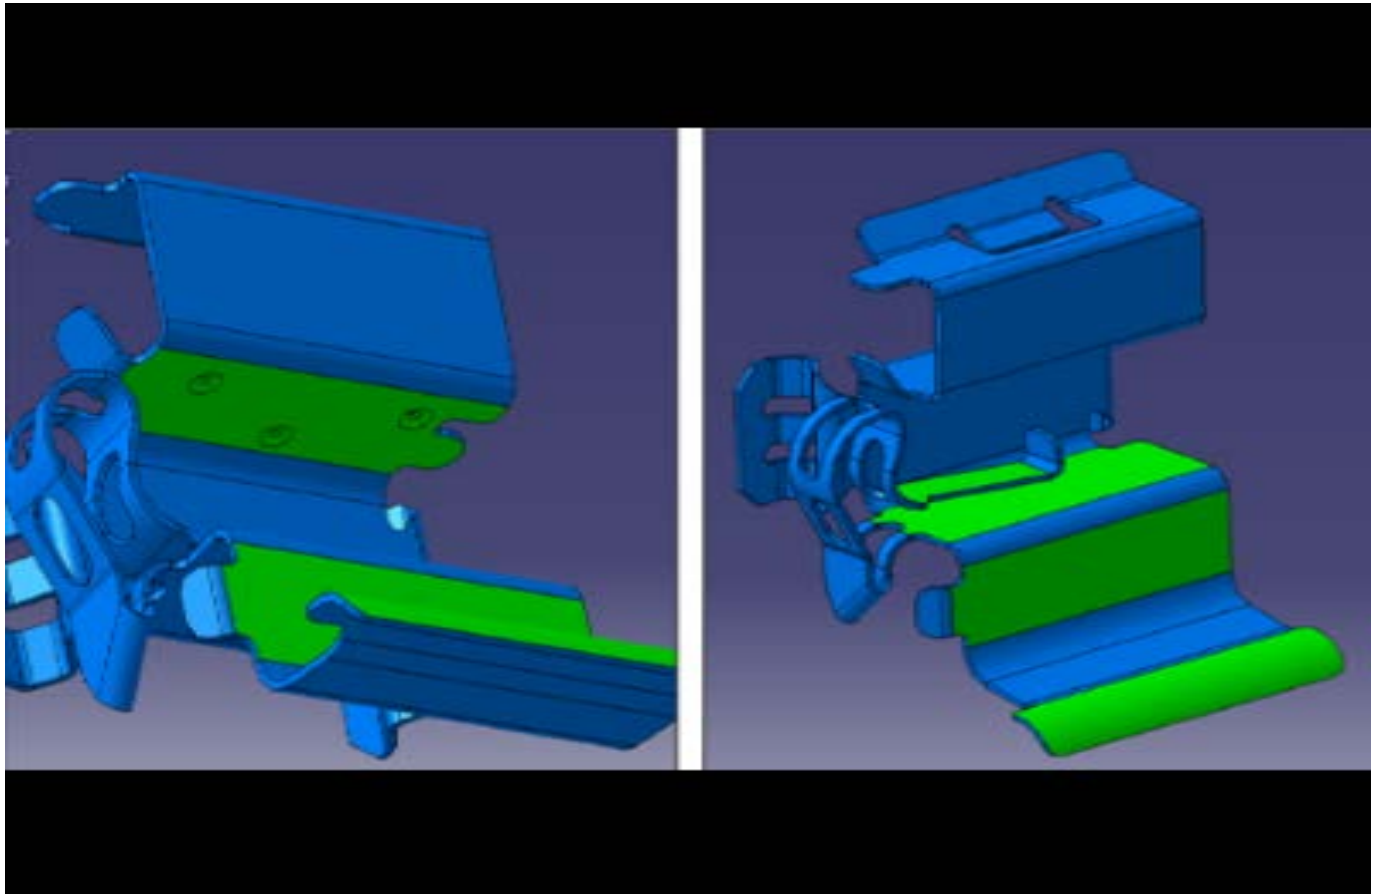
6077247

Note: The green area shown above designates the required grease positions.

3. Apply Molykote M-77 Grease (GM P/N 19356408) on caliper pad spring abutment and clip as shown in the graphic above.
4. Then reinstall the existing pads. Refer to *Front Disc Brake Pads Replacement* in the Service Manual.
5. Verify brake noise has been eliminated.

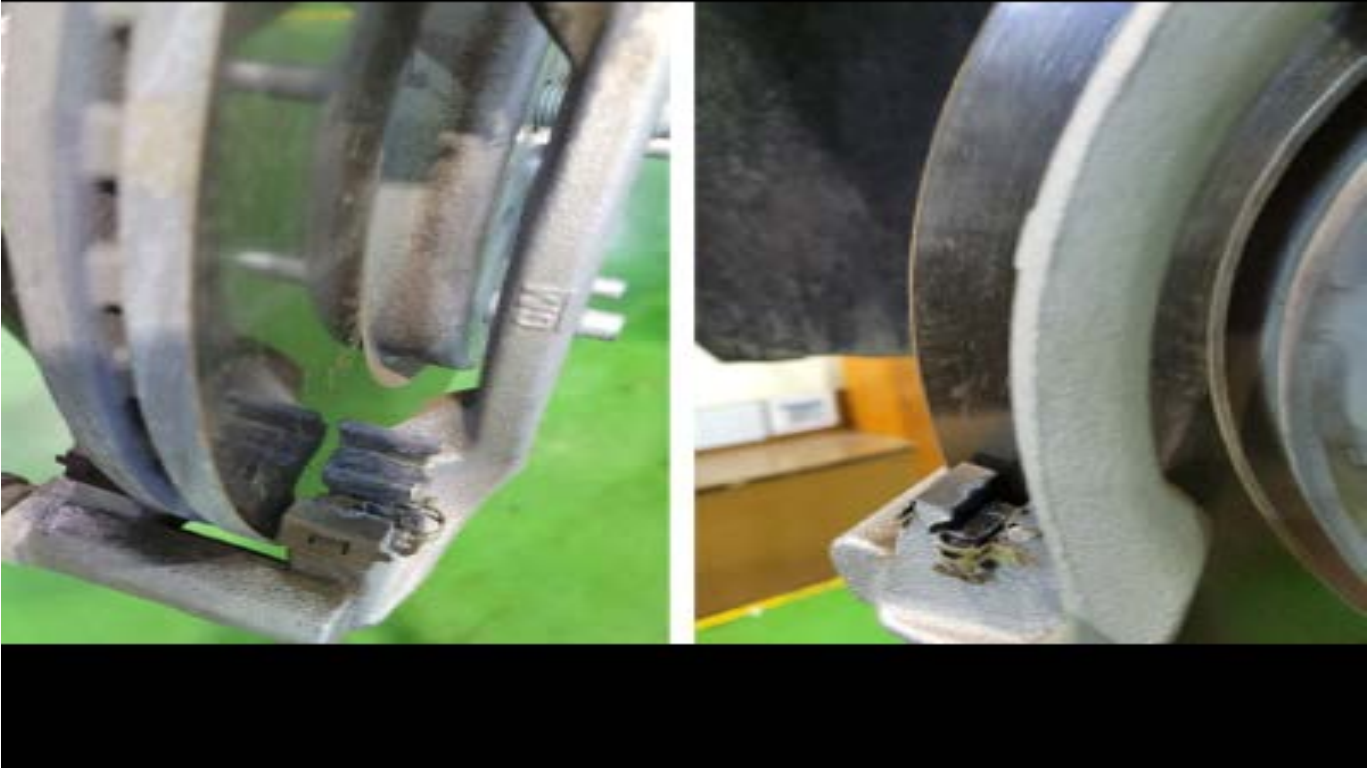
6077250

Note: The above graphics are actual grease adding examples.

2. Clean the pad spring abutment area on the caliper and anti-rattle clip.

Note: The recommended grease volume is about 1.1 g per caliper.
