Service Bulletin

Bulletin No.: 23-NA-107

Subject: Roof Related Water Leak, Key Fob Inoperative and/or Various Remote Control Door Lock Receiver (RCDLR) Concerns

Brand:	Model:	Model Year:		Vehicle Build Date:		Engine:	Transmission:
		from	to	from	to		
Chevrolet	Trax	2024	2024	SOP	April 07, 2023	All	All

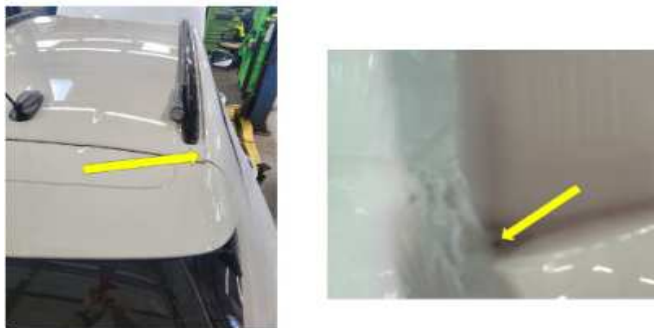
<p>[Redacted]</p> <p>6370899</p> <p>The cause of the condition may be a pin hole / poor sealing in the roof body seam or poor brazing weld. This condition could occur at either the front and/or rear, and on the right and/or left side or cross rail front stud not sealing to body of the vehicle.</p>

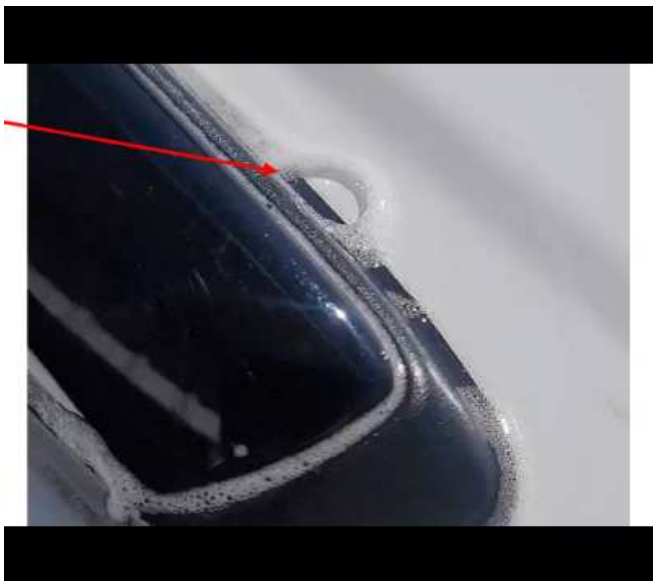
6445101

1. Visually inspect the front right and left roof laser braze, then the rear right and left roof laser braze, for pin holes or a crack.

2. Seal the holes/crack in any laser braze area following the steps below:
 - 2.1. Mix a small amount of Kent® High-Tech Seam Sealer Clear P10200, or Wurth Euroseal Gel Clear 18920104, or equivalent WITH the proper touch-up paint color.
 - 2.2. Avoiding excess sealer build-up within the ditch, work a small amount of the sealer into the hole with a gloved finger.
 - 2.3. Wipe away any excess sealer with a light amount of solvent on a rag or paper towel. The solvent will help the sealer flow into the hole/crack.
