GROUP	MODEL
BOD	2023MY Sorento (MQ4a)
NUMBER	DATE
321	October 2023

TECHNICAL SERVICE BULLETIN

SERVICE ACTION: WINDSHIELD WATER RAIL GARNISH REPLACEMENT (SA551)

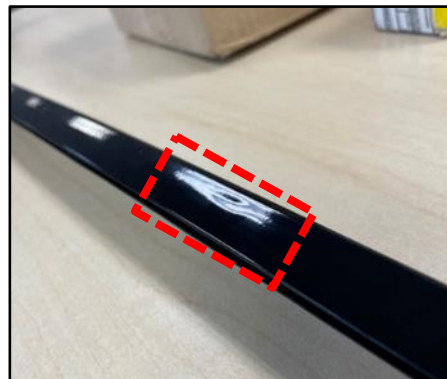
This bulletin provides information to replace the left (driver) windshield water rail garnish on certain 2023MY Sorento (MQ4a) vehicles produced from September 18, 2023 through September 21, 2023. The affected vehicles may have obtained a dimple on the left (driver) windshield water rail garnish during manufacturing process at the factory. Follow the procedure outlined in this publication to replace the left (driver) windshield water rail garnish on the applicable vehicle. Before conducting the procedure, verify that the vehicle is included in the list of affected VINs.
