GROUP	MODEL
ELE	2015-2017MY Soul EV (PS EV)
NUMBER	DATE
310	October 2023

TECHNICAL SERVICE BULLETIN

HIGH-VOLTAGE BATTERY PACK AND BATTERY MANAGEMENT SYSTEM

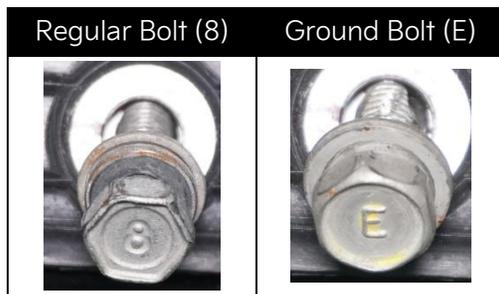
Mark the six (6) 'ground' bolts and their location to prevent mixing with regular bolt prior to reassembly.

Ground Bolt (E): 6 ea.

Regular Bolt (8): 35 ea.

1. Remove the BPA upper case (A) by referring to "EV Battery System → High Voltage Battery System → Case → Repair procedures (Removal)" in the applicable Shop Manual on KGIS. Refer to KGIS for bolt/nut torque specs.

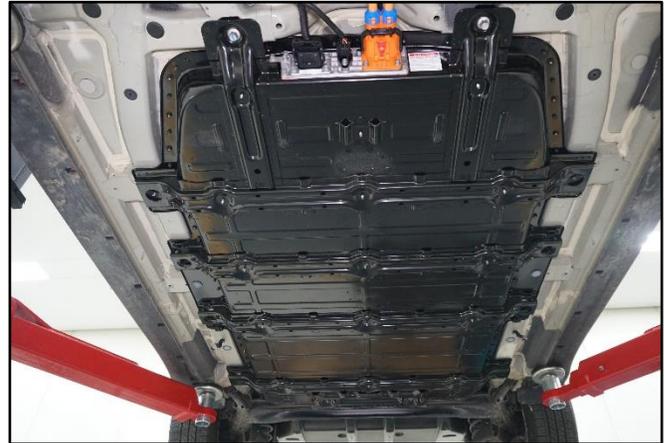
15-17MY ONLY new BPA is equipped with an "old" type harness. Be sure to install the "new" type harness.

1. Remove the HV BPA by referring to "EV Battery System → High Voltage Battery System → Battery Pack Assembly → Repair procedures (Removal)" in the applicable Shop Manual on KGIS.

Note: SST OK375 E4300 BPA lifting jig and crane jack (A) are required.

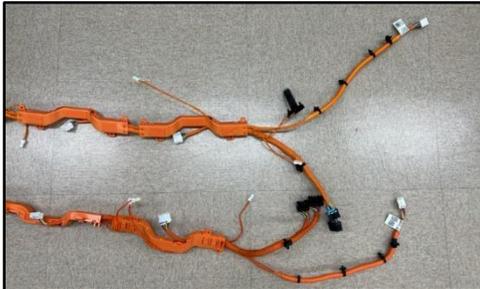
Note: The new harness is different for the removed harness when compared side by side.

- Replace the two voltage temperature sensor wire harnesses (VTSWH) with the 'new' parts.

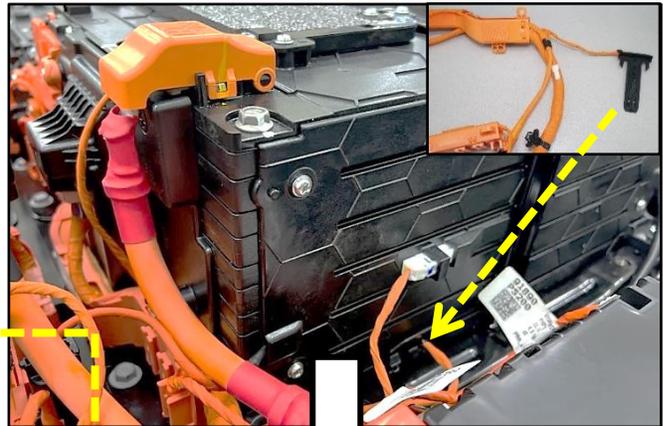
Note: Some vehicles may have a remaining temperature sensor connector hole. If so, disregard, no need to connect to it.

- During re-assembly, insert the battery temperature sensor into the battery pack lower side area shown.

Connect the outside temperature sensor connector where shown.
