GROUP	MODEL
ELE	2019-2022MY Niro EV (DE EV)
NUMBER	DATE
270 (Rev 2, 10/23/2023)	April 2023

TECHNICAL SERVICE BULLETIN

SUBJECT: **FLUSHING/REPLACEMENT FOR CLUSTER MESSAGE
"REFILL INVERTER COOLANT" (SA512)**

This issue number is SA512.

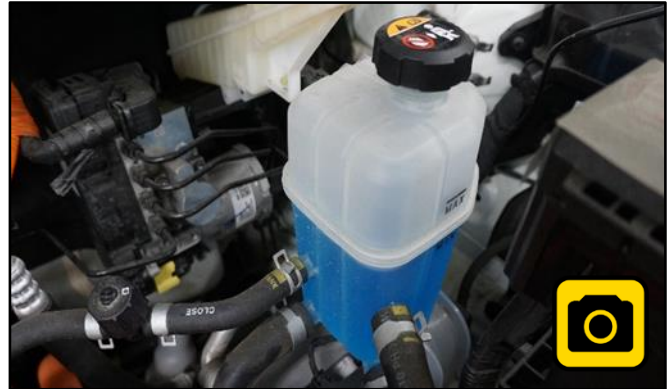
1. If the vehicle has General Type Coolant (green), **this service action does not apply.**

If the vehicle has Low-Conductivity Coolant (BSC-1) (blue), continue to step 2 to replace it with (BSC-2) to complete this service action.

Submit a KVID photo of the green coolant filled reservoir and use Op Code 230020R2.
