Technical Service Bulletin

57J3 UPDATE

Door Seam Cavity Sealing – (NVLW)

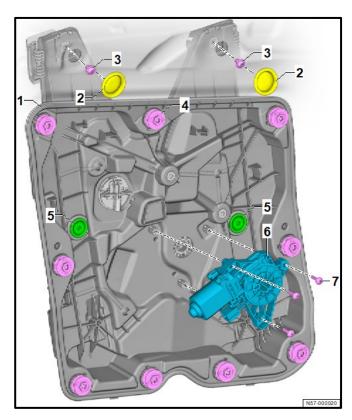
- Remove both front and rear supports for door components per the ELSA repair manual:
 - Front doors: Repair manual > Body >
 Body Exterior > 57 Front Doors,
 Central Locking System > Door
 Components > Support for Door
 Components, Removing and Installing
 - Rear Doors: Repair manual > Body >
 Body Exterior > 58 Rear Doors > Door
 Components > Support for Door
 Components, Removing and Installing

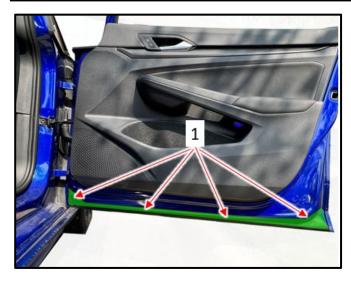
The area where cavity wax is to be applied **INSIDE** the door <1> is shown from the outside for clarity. **CAVITY WAX IS ONLY TO BE APPLIED INSIDE THE DOOR, NOT THE OUTSIDE!**

Apply cavity wax to the inside of all four doors at the lower seams in the area indicated <arrows>.

The cavity wax should be applied the length of the seams.
