Service Update

SU 2302 7.3L RADIATOR COOLANT LEAKS

Models Affected: Model Year 2021 thru current model BBCV buses equipped with Ford 7.3L engine.

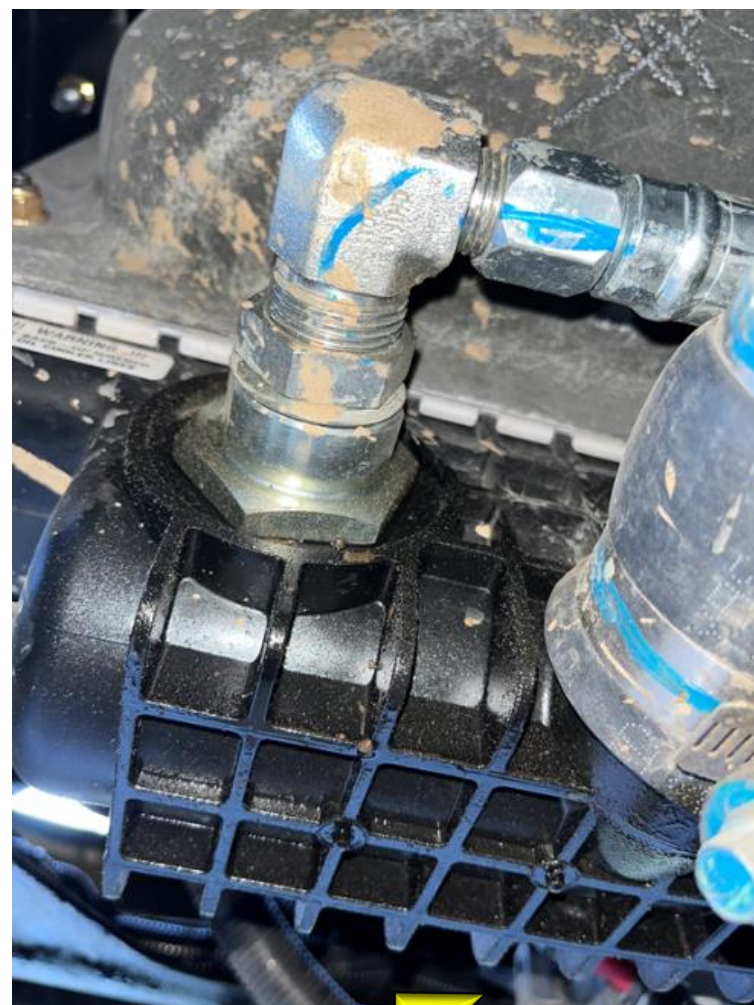
Issue: Coolant leaks at the transmission cooler fitting(s) have been found on certain radiators due to deformation of the EPDM gasket used to seal the transmission cooler to the lower radiator tank. This deformation is caused from transmission oil wicking through the thread adapter threads and exposing the lower portion of the gasket to transmission oil.

- 1) Identify coolant leaks are sourcing from the large chrome steel nut(s) on the bottom of the radiator as shown in the photo above.
- 2) If the leak is not present, no further action is required. If the leak is present, continue to Step 3.
