Service Update

SU 2302 7.3L RADIATOR COOLANT LEAKS

Models Affected: Model Year 2021 thru current model BBCV buses equipped with Ford 7.3L engine.

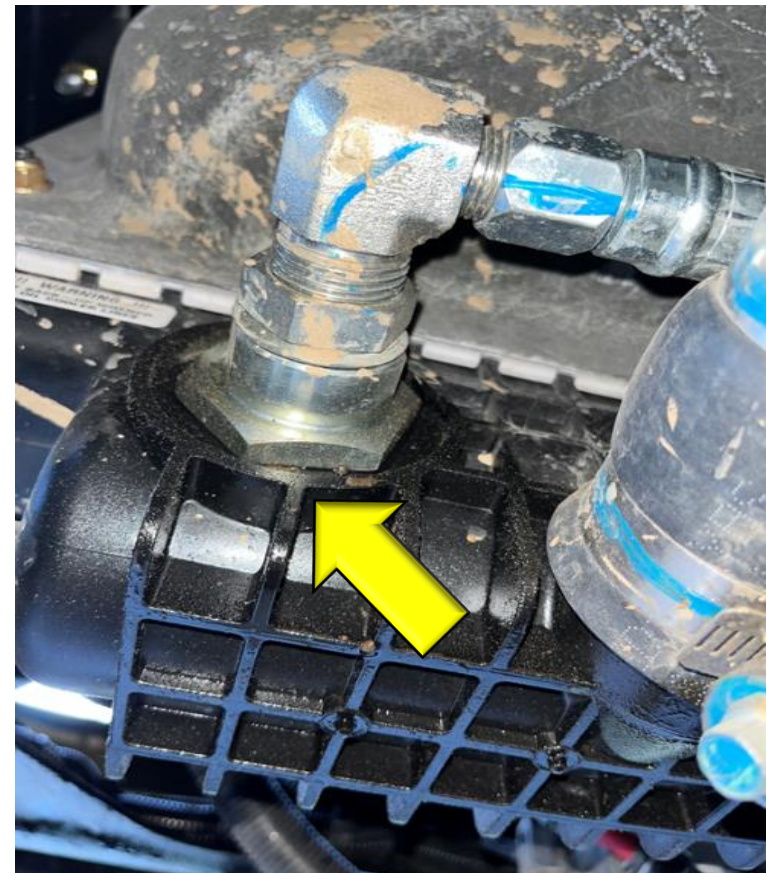
Issue: Coolant leaks at the transmission cooler fitting(s) have been found on certain radiators due to deformation of the EPDM gasket used to seal the transmission cooler to the lower radiator tank. This deformation is caused from transmission oil wicking through the thread adapter threads and exposing the lower portion of the gasket to transmission oil.

- 1) Identify coolant leaks are sourcing from the large chrome steel nut(s) on the bottom of the radiator as shown in the photo above.
- 2) If no leak present, no further action required. If leak is present, proceed to step #3.

Corrective Action: Re-configure hydraulic interface between the transmission cooler lines and the transmission oil cooler.

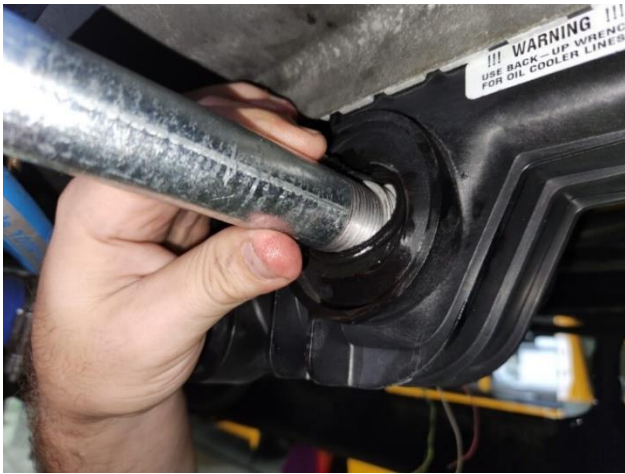
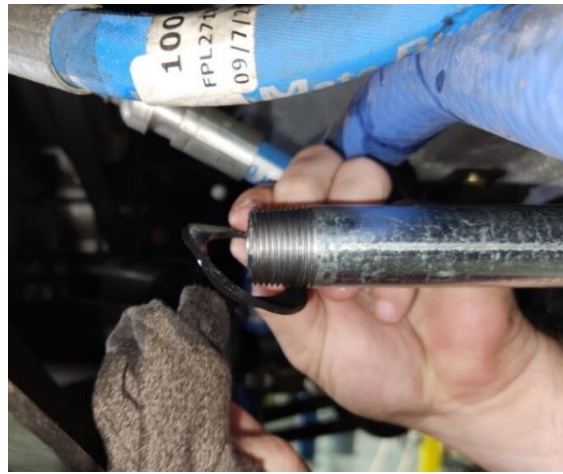
NOTE: Take your time here because any leftover Loc-Tite™ will inhibit the new nuts from threading on without galling the threads. The cooler is aluminum.

11) Using the same pick, remove hardened Loc-Tite™ from the trans cooler threads.
