GLOBAL SAFETY FIELD INVESTIGATIONS  
DCS6698  
URGENT - DISTRIBUTE IMMEDIATELY

Subject: N232413570 - Service Update  
Loose Front Suspension Fasteners

Models: 2023 BrightDrop Zevo 600

## N232413570 Loose Front Suspension Fasteners

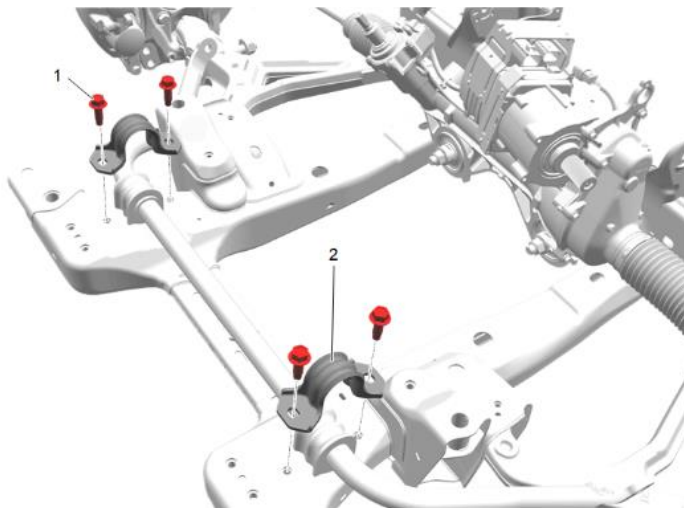
5830690

3. Use the provided crows-foot style extension tool and approach from the rear of the vehicle in the center of the subframe in order to access the sway bar bolts, as shown.

4. Using a torque wrench and the special tool extension, torque Front Stabilizer Bar Bracket fasteners (1) with the torque wrench set to the calculated value, determined in step 2.
5. Lower the vehicle. Refer to *Lifting and Jacking the Vehicle* in SI.
