Service Bulletin

Bulletin No.: 16-NA-334

Subject: Water Leak/Drips at Left or Right Side of Windshield Header/A-Pillar Area

Brand:	Model:	Model Year:		VIN:		Engine:	Transmission:
		from	to	from	to		
Chevrolet	Camaro Convertible	2016	2024	—	—	All	All

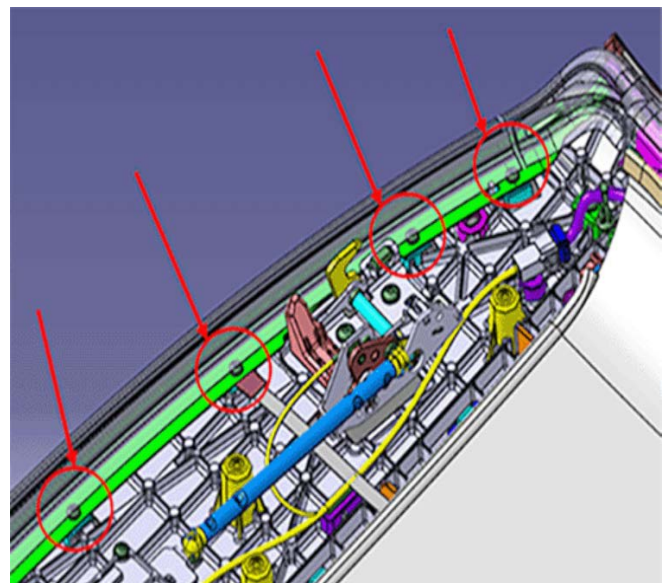
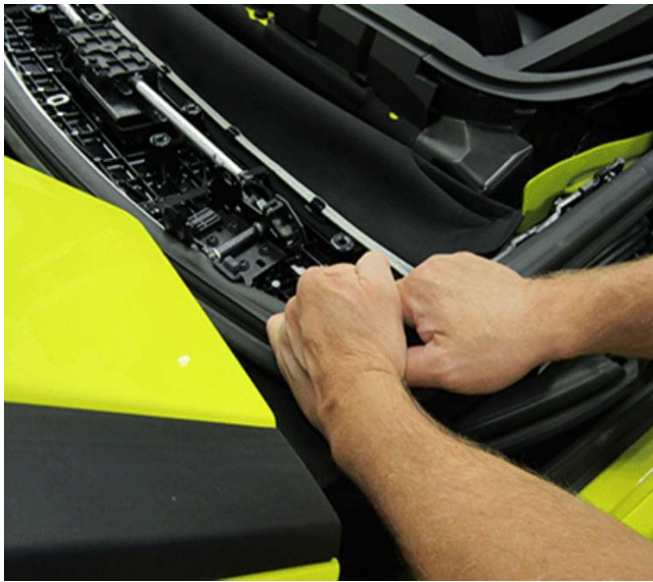
1. Fully open the folding top.
2. Loosen the four outboard front weatherstrip retainer screws on the affected side.

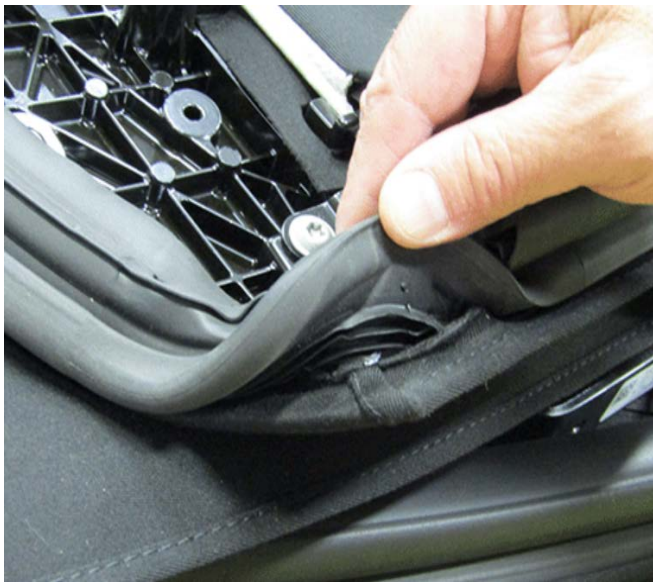
4588943

3. Pull the weatherstrip, stretching it to gain some additional length in the corner.

4. Refit the corner until it lines up with the stitch line of the top cover fabric.
5. Retighten the four screws to hold the weatherstrip in place.

Tighten the screws to 9 N•m (80 lb in).
