## STAR ONLINE PUBLICATION

**Case Number:** S2319000008

**Symptom/Vehicle Issue:** Clicking Noise From Steering Column While Turning Steering Wheel.

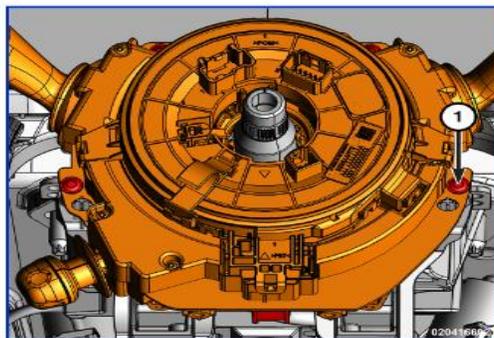
1 - SCCM Bracket Screws

**Discussion:** The click noise may be from the steering column control module (SCCM) area. Inspection will require removal of the steering wheel. Refer to Service Library Service Information 19 - Steering / Column / WHEEL, Steering / Removal and Installation and also 08 - Electrical / 8E - Electronic Control Modules / MODULE, Steering Column Control (SCCM) / Removal and Installation. With the steering wheel removed, inspect the SCCM for being fully seated. If the SCCM does not appear seated to the column, Remove and reinstall the SCCM.
