Case Number: S2321000005 REV. A

Symptom/Vehicle Issue: Transmission Fluid Leak From Under The Vehicle.

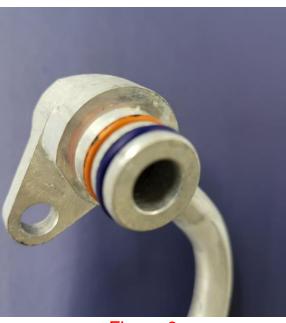
Figure 3

b. Closely inspect the TOC line seals (Figure 3) for damage and replace as necessary. Tighten the retaining bolts to the proper torque, clean the affected area, and retest for the leak.

- 1. Referring the potential leak points above, thoroughly clean each area using brake parts cleaner.
- 2. Apply suitable leak detection powder to the affected areas.
- 3. Start and run the vehicle on a suitable hoist until the vehicle reaches full operating temperature. If the leak cannot be duplicated on the hoist, take the vehicle on a thorough test drive to duplicate it.
- 4. Inspect the potential leak points for signs of the leak. If necessary, use a UV Blacklight to locate the leak.
- 5. Repair any leaks found as necessary. Leaks due to case porosity, will require transmission replacement.
