## STAR ONLINE PUBLICATION

**Case Number:** S2308000074 Rev. A

**Symptom/Vehicle Issue:** Central ADAS Decision Module (CADM), Advanced Driver Assist System (ADAS), Lane Assist Inoperative, Service Active Lane Management Message

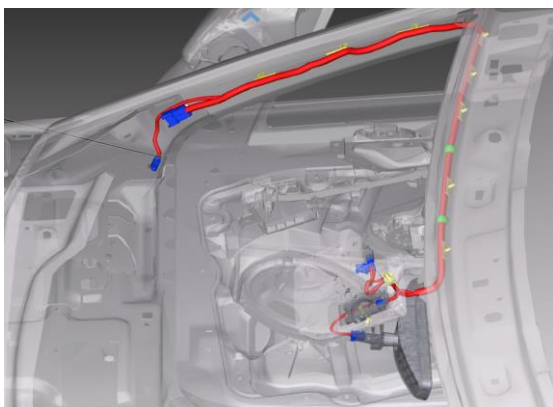
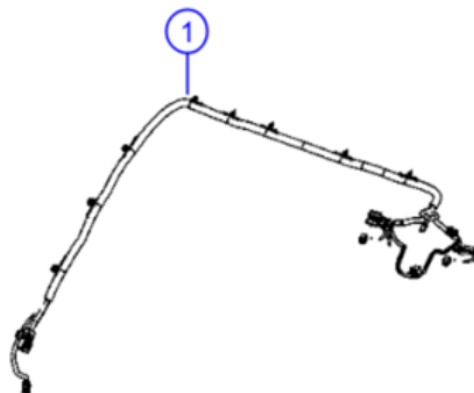
## Figure 1: LRCF Front Mirror Harness

Some recently replaced and returned Long Range Front Cameras (LRCFs) and CADM(s) were tested and have been found to have no internal failures. Upon further inspection the technician may not find any obvious signs of damage to the wiring or connectors after some recent vehicle repairs. However, some critical inspection points of the LVDS/Coax Cable after all repairs to interior trim or the windshield can be helpful to root cause the signal disruption misleading to replacement of the LRCF or CADM before identifying issues with the LVDS/Coax Cable.

1. **Mirror Harness Connection looped over to tightly causing tension.**
2. **Mirror Harness Front Camera Connector Rotated 90 Degrees which may partially spread the terminals(check pin fit as needed).**
3. **Pinch or Chaffing of the Mirror Harness by the Interior Trim clips.**

Start your diagnosis with replacement of the mirror harness for any suspect damage (Figure 1).
