STAR ONLINE PUBLICATION

Case Number: S2323000074

Symptom/Vehicle Issue: Buzz Squeak Rattle (BSR) From Sound Bar Or Sport Bar Area.

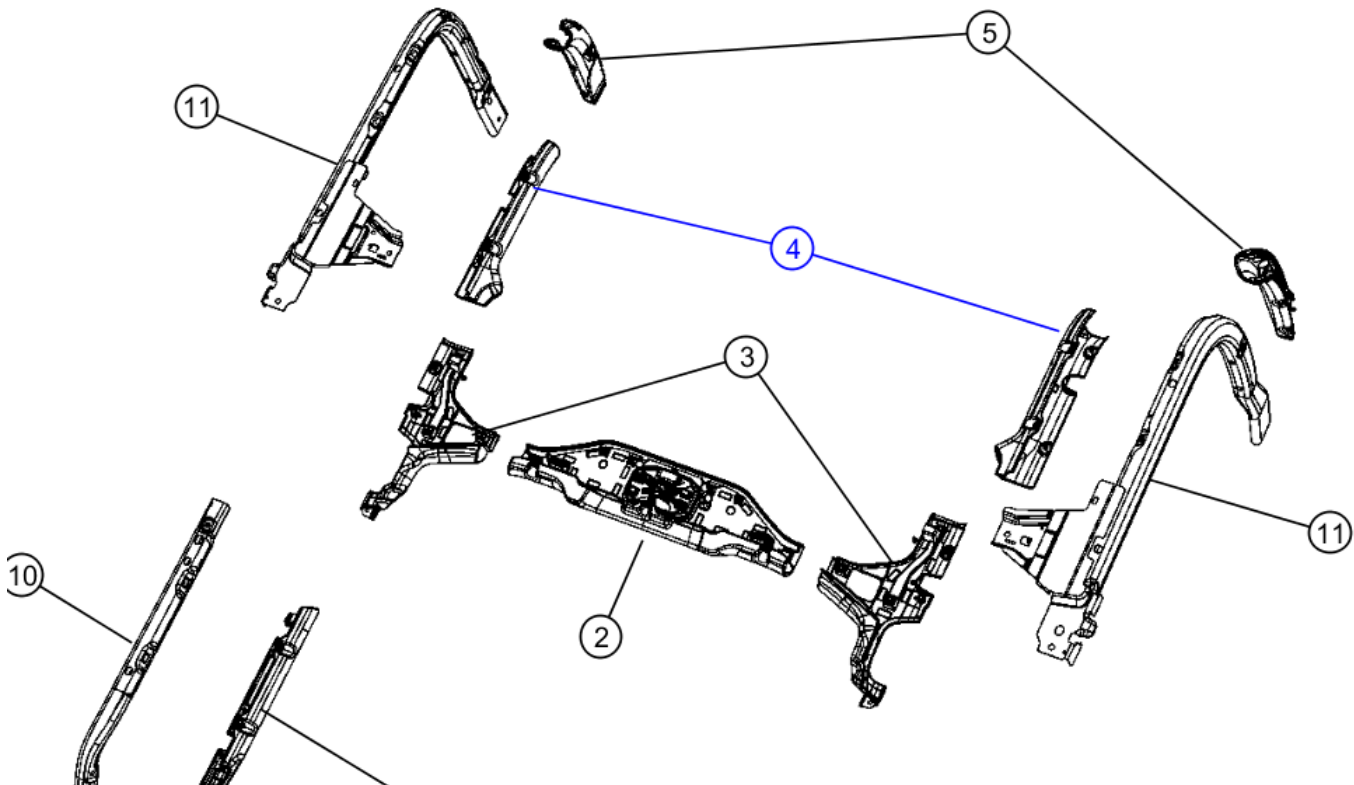
Fig 1.
Sport Bar Trim Item 4.

Discussion: Using a helper to drive, duplicate the conditions necessary to create the BSR. Press upward on the sport bar trim to isolate the vibration (item 4 in Fig 1 below). If the noise is lessened or resolved with hand pressure, proceed with installing foam as shown below.

Remove the sport bar trim using a T25 torx bit. Review the foam application areas. Using isopropyl alcohol, wipe the area where foam is to be applied to remove grease, oils and dirt that may be present. Apply Mopar foam 68053426AA or 68643986AA on the underside of the sport bar trim as shown in Fig 2. Install foam on both right and left-hand sport bar trim as shown.

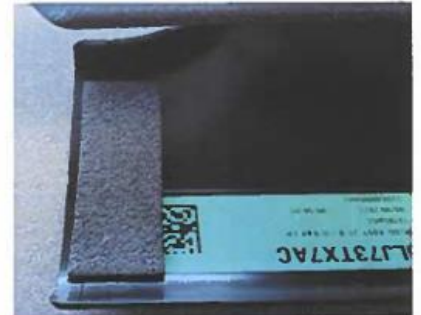
Fig 2.
Sport Bar Trim Removed. Foam application shown.

B-D Mldg/Trim Left and Right equal

Foam placement on part

Close-up but not over edge
