REFERENCE:	TSB: 24-012-23 GROUP 24 - Heating and Air Conditioning	Date:	September 1, 2023	REVISION:	-
VEHICLES AFFECTED:	2022 - 2024 (M6) Jeep Compass 2023 - 2024 (H6) Jeep Meridian This bulletin applies to vehicles built on or after November 01, 2022 (MDH 1101XX) and on or before July 16, 2023 (MDH 0716XX).	MARKET APPLICABILITY:			
CUSTOMER SYMPTOM:	Customers may comment on one or more of the following: <ul style="list-style-type: none"> Defroster grill is coming loose and popping up from the corner area - both left and right hand side. Defroster grill is not flush with the instrument panel. 				
CAUSE:	Shrinkage in the defroster grill due to improper cooling process.

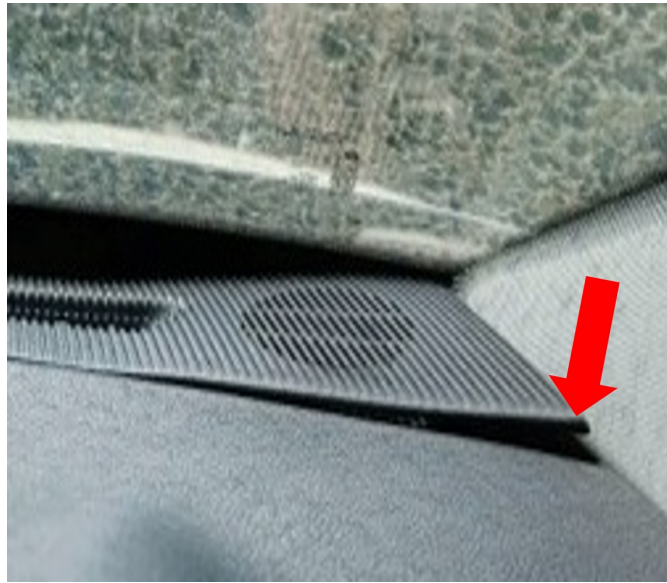
1. Is the vehicle build date between April 11, 2023 to July 16, 2023?
 - YES>>> Proceed to [Step 4](#).
 - NO >>> The vehicle build date is between November 01, 2022 and April 10, 2023. Proceed to [Step 2](#).
2. Inspect the defroster grille for deformation and/or not flush to the instrument panel ([Fig. 1](#)) .

Fig. 1
Deformed Defroster Grille

3. Was the defroster grille deformed or not flush to the instrument panel ([Fig. 1](#)) ?
 - YES>>> Proceed to [Step 4](#).
 - NO>>> This bulletin has been completed, use Inspect LOP (23-11-14-90) to close the active RSU.
4. Replace the defroster grille. Refer to the detailed service procedures available in DealerCONNECT/ Service Library under: Service Info> 23 - Body / Instrument Panel / Grille, Defroster / Removal and Installation.
