REFERENCE:	TSB: 23-096-23 GROUP: 23 - Body	Date:	September 12, 2023	REVISION:	-
VEHICLES AFFECTED:	2023 (WS) Grand Wagoneer/Wagoneer This bulletin applies to vehicles built on and after June 06, 2023 (MDH 0606XX) and on and before June 16, 2023 (MDH 0616XX).			MARKET APPLICABILITY: <input checked="" type="checkbox"/> NA <input type="checkbox"/> CH <input type="checkbox"/> EE <input type="checkbox"/> IAP <input type="checkbox"/> SA <input type="checkbox"/> MEA	
CUSTOMER SYMPTOM:	Customers may experience one or more of the following: <ul style="list-style-type: none"> • Right side quarter glass tint is mismatched. • Right side of the vehicle allows more road noise into the vehicle. 				
CAUSE:	Incorrect right side quarter glass installed.

This bulletin involves inspecting and possibly replacing the right side quarter glass.

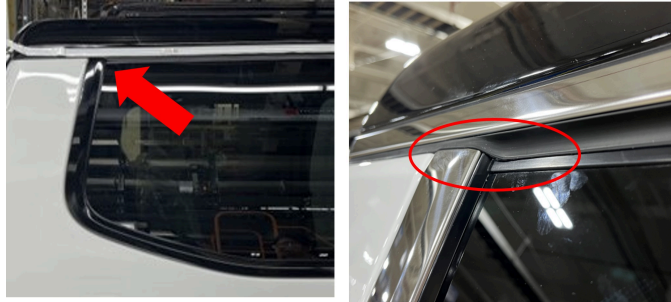
1. Inspect right side quarter glass for a "step", at the top of the glass to its molding (just below the window seal at the D-pillar) [Fig. 1](#) and [Fig. 2](#).

Fig. 1
Incorrect Right Side Quarter Glass

1. Replace the right side quarter glass. Refer to the detailed service procedures available in DealerCONNECT> Service Library under: Service Info>23 - Body / Stationary Glass / Glass / Removal and Installation.

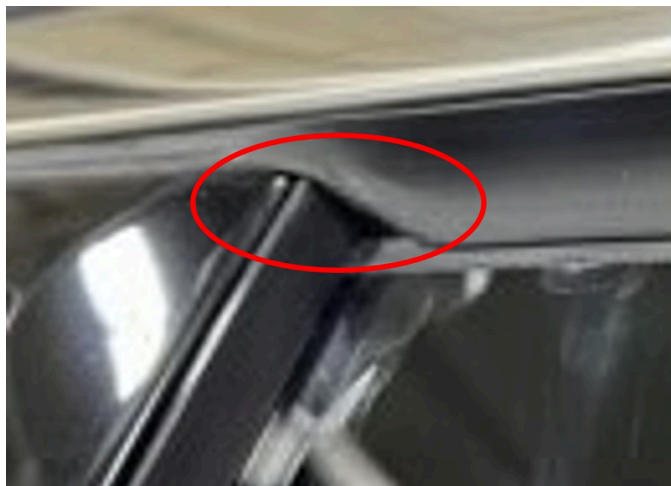
Fig. 2
Molding "Step" At The Top Of The Glass
