REFERENCE:	TSB: 23-097-23 GROUP: 23 - Body	Date:	September 16, 2023	REVISION:	-
VEHICLES AFFECTED:	2023 (WS) Grand Wagoneer/Wagoneer This bulletin applies to vehicles built on or after January 24, 2023 (MDH 0124XX) and on or before February 01, 2023 (MDH 0201XX).			MARKET APPLICABILITY:	
				<input type="checkbox"/> NA	<input type="checkbox"/> CH
				<input type="checkbox"/> EE	<input type="checkbox"/> IAP
				<input type="checkbox"/> SA	<input checked="" type="checkbox"/> MEA
CUSTOMER SYMPTOM:	Incorrect gray stitching on steering wheel (correct stitching on steering wheel should be brown as found on the air bag) Fig. 1 .				
CAUSE:	Incorrect gray stitching on steering wheel.

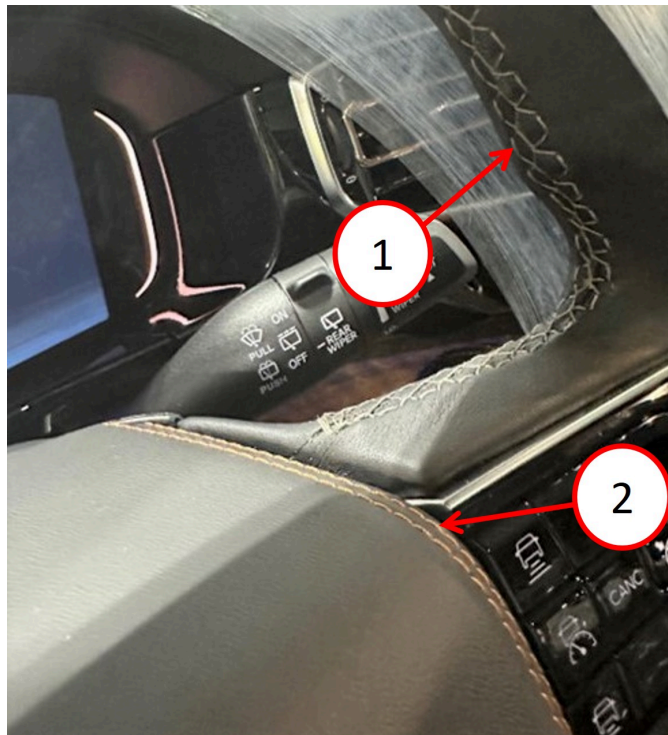
Fig. 1
Incorrect And Correct Steering Wheel Stitching

1 - Incorrect Gray Steering Wheel Stitching
2 - Correct Brown Steering Wheel Stitching Found On Air Bag

This bulletin involves replacing the steering wheel.

1. Replace the steering wheel. Refer to the detailed service procedures available in DealerCONNECT/ Service Library under: Service Info>19 - Steering / Column / Wheel, Steering / Removal and Installation.
