REFERENCE:	TSB: 08-052-23 REV. A GROUP: 08 - Electrical	Date:	September 30, 2023	REVISION:	08-052-23						
VEHICLES AFFECTED:	<p>**2022** - 2023 (DT) RAM 1500 Pickup **2022 (DJ) RAM 2500 Pickup 2022 (DD) RAM 3500 Cab Chassis 2022 (D2) RAM 3500 Pickup 2022 (DP) RAM 4500/5500 Cab Chassis 2022 (DF) RAM <10K Cab Chassis**</p> <p>This bulletin applies to vehicles equipped with one of the following radios:</p> <ul style="list-style-type: none"> • Uconnect 5 NAV W 12" Display (Sales Codes UPQ, UFQ, UBQ or UEQ) **Without Surround View Camera System (-XAK).** • Uconnect 5 Nav W 8.4" Display (Sales Codes UFL, UPL, UBL or UEL) **Without Surround View Camera System (-XAK).** 			<p>MARKET APPLICABILITY:</p>

REPAIR SUMMARY:

This bulletin involves inspecting the software level and updating the software to:

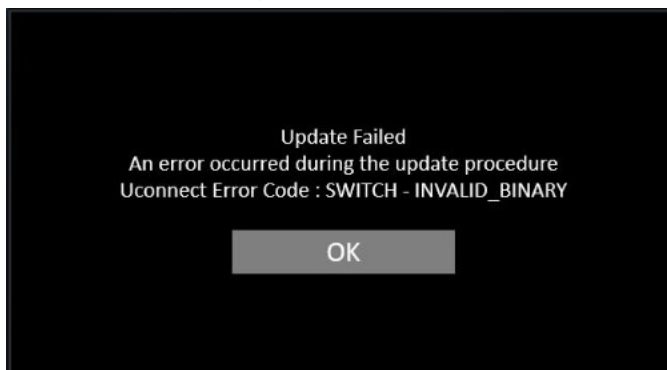
16. Sometimes the radio will display an error pop up “ SWITCH - INVALID_BINARY“ after successful radio update. Please ignore this error message and press “OK” to continue [Fig. 5](#).

Fig. 5
Error Message
