Technical Service Bulletin

55 Fuel filler door to side panel incorrect fitment

55 23 81 2071697/1 October 24, 2023.

Model(s)	Year	VIN Range	Vehicle-Specific Equipment
Q8, SQ8, and RS Q8	2021 – 2025	All	Internal Combustion Engine

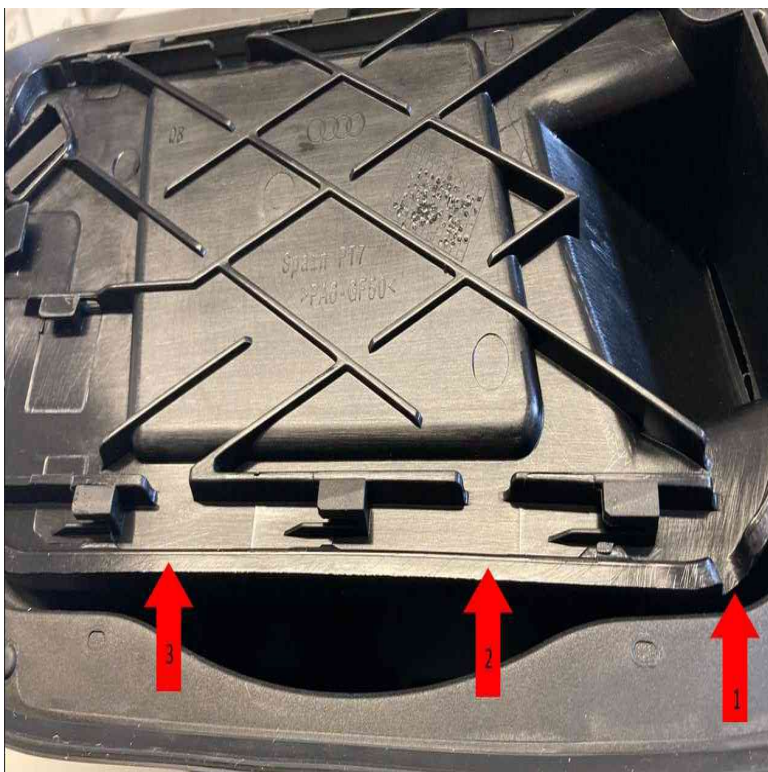
Figure 1. Adding two water drains in positions #2 & #3.

1. Replace the fuel filler door insert according to: *Elsa>>Repair manual>>Body>>Body Exterior>>55 Hood, Lids>>Fuel Filler Door Unit>> Fuel Filler Door Unit, Removing and Installing.*
2. Do not discard the original fuel filler door! The original fuel filler door (with original paint finish) must be reinstalled.
3. The painted fuel filler door must be bonded/sealed additionally to the fuel filler door insert.
4. The new fuel filler door insert is equipped with one water drain in position #1. Two additional water drains must be created in positions #2 and #3 (Figure 1).

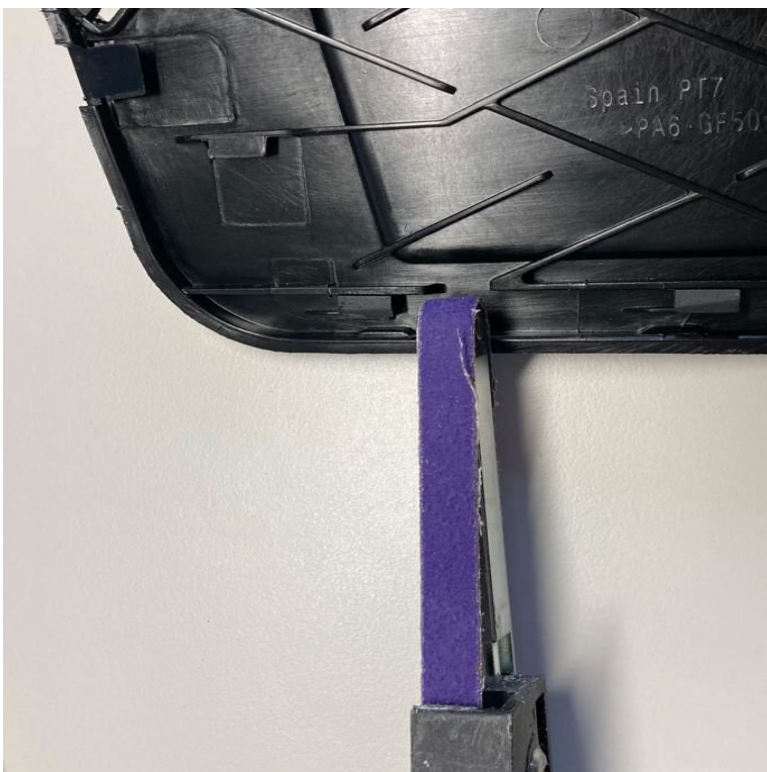
Figure 2. Use a belt sander to make additional drains.

5. Make two additional water drains using a belt sander (Figures 2 – 4).

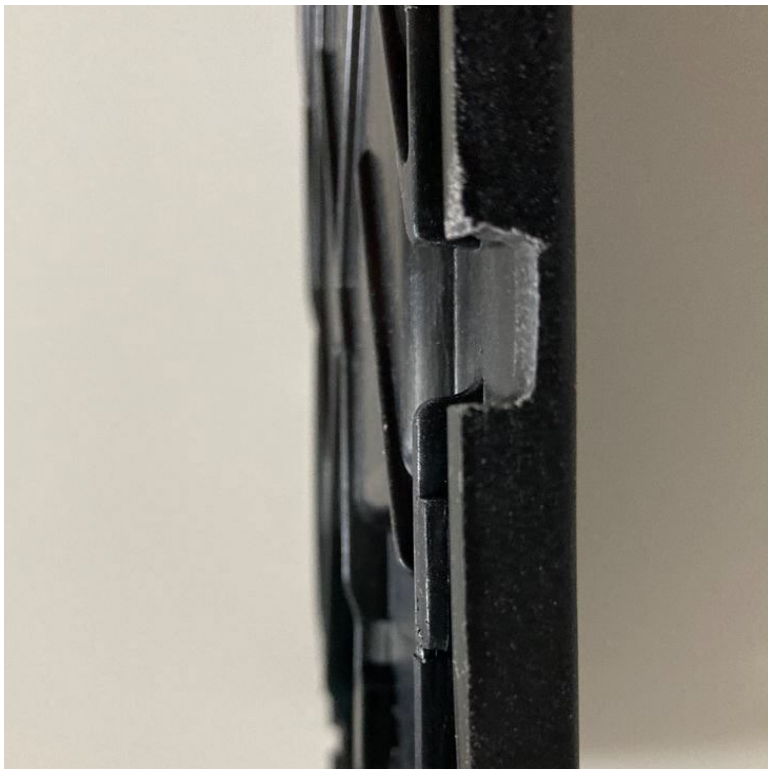
Figure 3. One of the new water drains.

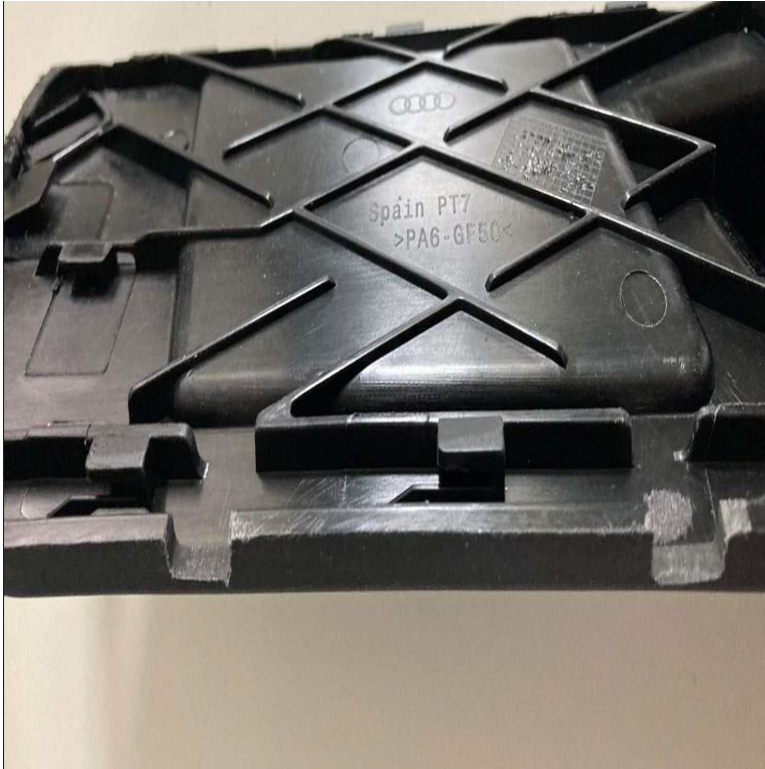
Figure 4. Both newly added water drains.

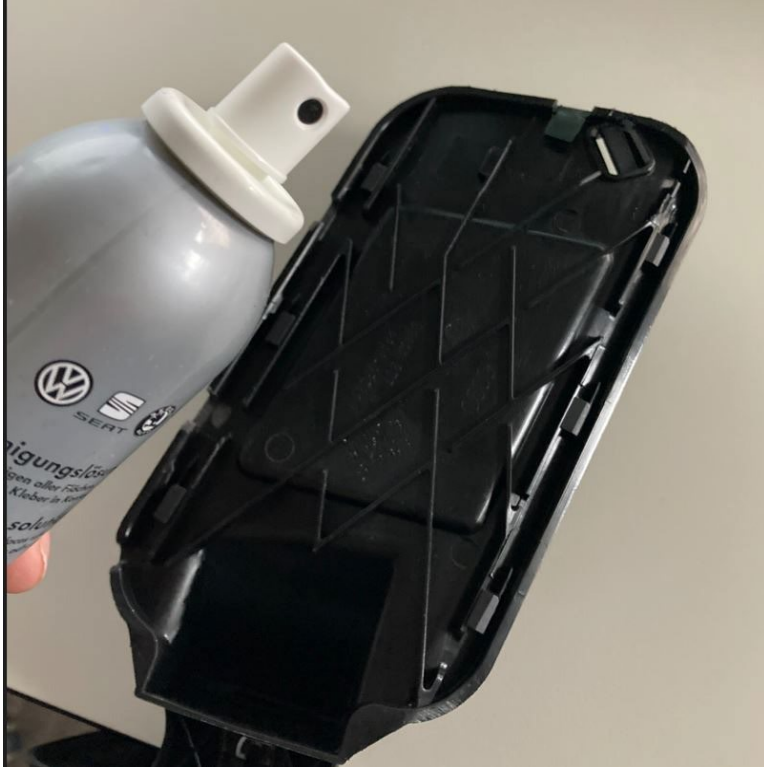
Figure 5. Clean the fuel filler door and insert with all purpose cleaner.

6. Clean the fuel filler door insert where it contacts the fuel filler door as well as the backside of the fuel filler door with all purpose cleaner D00940104. Observe flash-off/drying time (Figure 5).

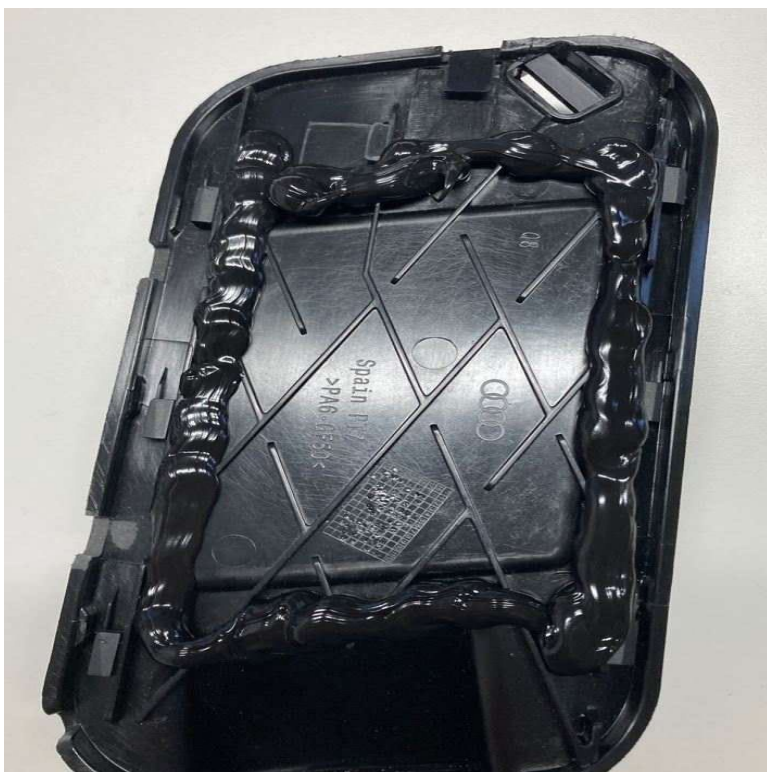
Figure 6. Adhesive applied to the fuel filler door insert.

7. Apply a bead of adhesive (D190MKDA3 or D172090M2) on the inside area of the bracket. Do not apply any adhesive in the area of the fuel filler door actuator bracket (Figure 6)!

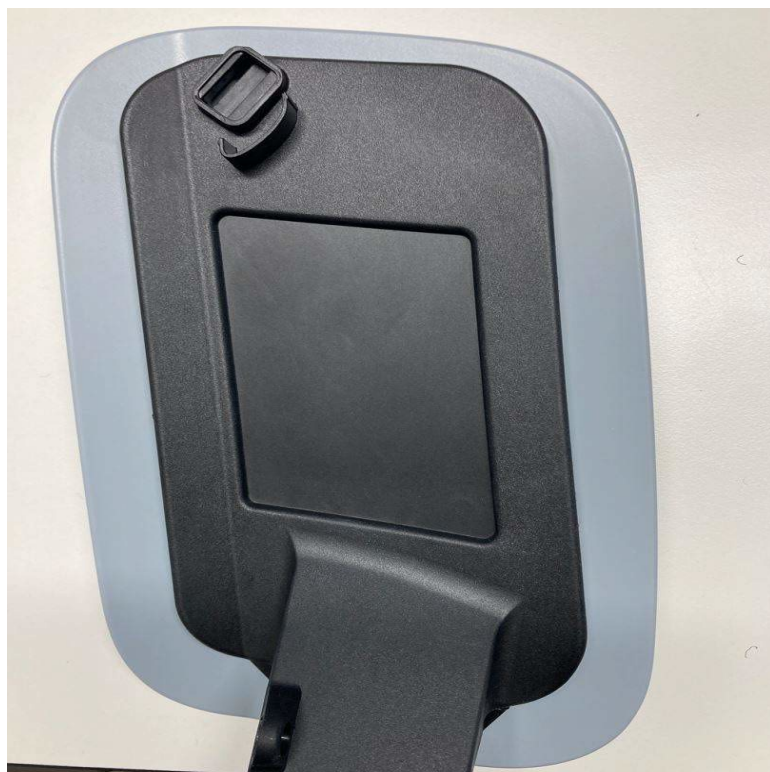
Figure 7. Original fuel filler door installed with excess adhesive removed.

8. Reinstall the original fuel filler door on the modified fuel filler door insert immediately. Remove any excess adhesive as quickly as possible (Figure 7)!
