# Technical Service Bulletin

## 60 Water entry into cabin from the sunroof area

60 23 69 2056944/10 October 12, 2023. Supersedes Technical Service Bulletin Group 60 number 23-67 dated August 23, 2023, for reasons listed below.

Model(s)	Year	VIN Range	Vehicle-Specific Equipment
Q3, and Q8	2019 – 2021	All	Not Applicable
e-tron quattro	2019 2021		
e-tron Sportback quattro, SQ8, and RS Q8	2020 - 2021

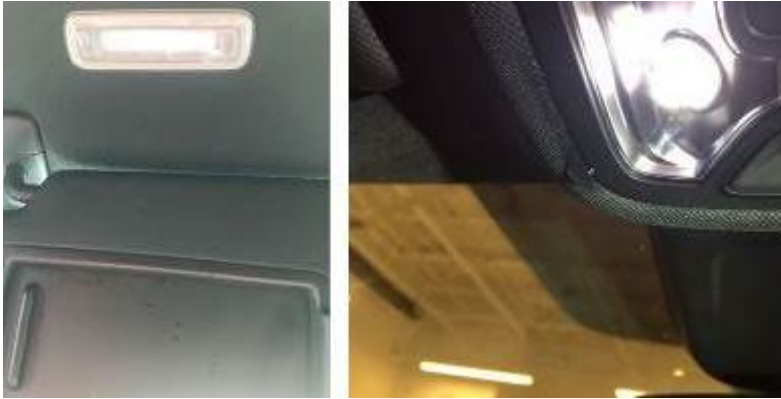
- There is a water drip from the headliner area (figure 1).

**Figure 1.** Water intrusion near the headliner.

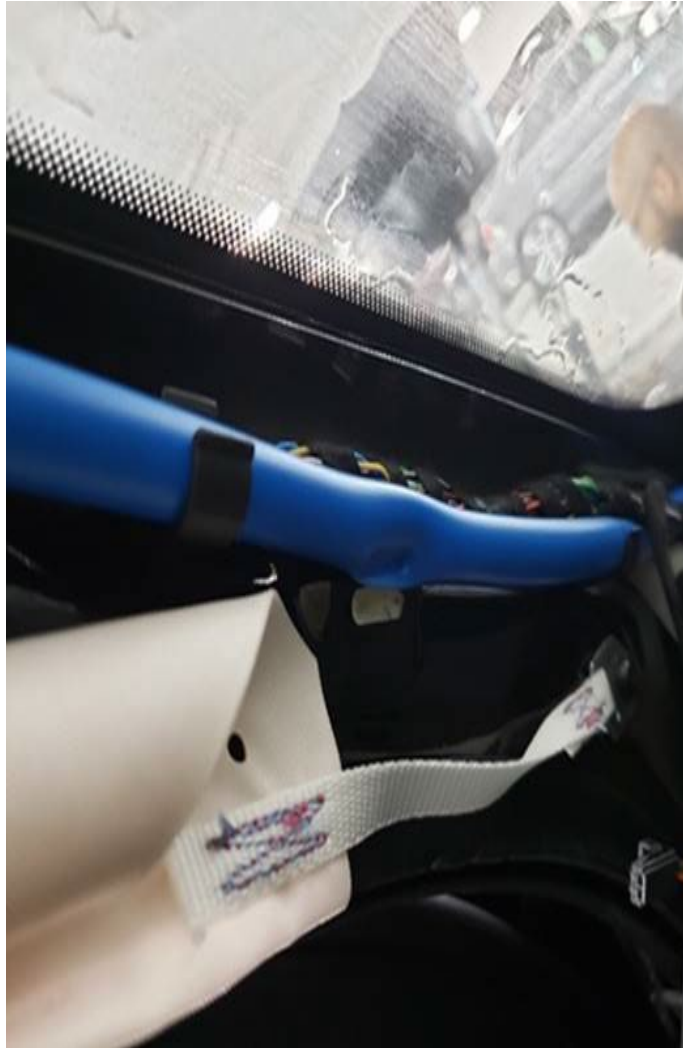
Using the VAS6620 Sunroof Drain Snake follow the cleaning procedure for the sunroof water drain hoses as described in ElsaPro. Any possible obstruction other than debris cleared by this procedure will be apparent after this check such as a kinked or pinched drain hose (Figure 3).

*Figure 3. Sunroof drain hose pinched by the pillar trim.*

Ensure that any water in the sunroof frame drainage areas flows freely after the cleaning procedure. If any obstruction is due to a pinched or kinked drain hose the damaged drain hose(s) or valve(s) must be replaced. Refer to ElsaPro for inspection and repair procedures as well as the claiming labor operations and SRTs.

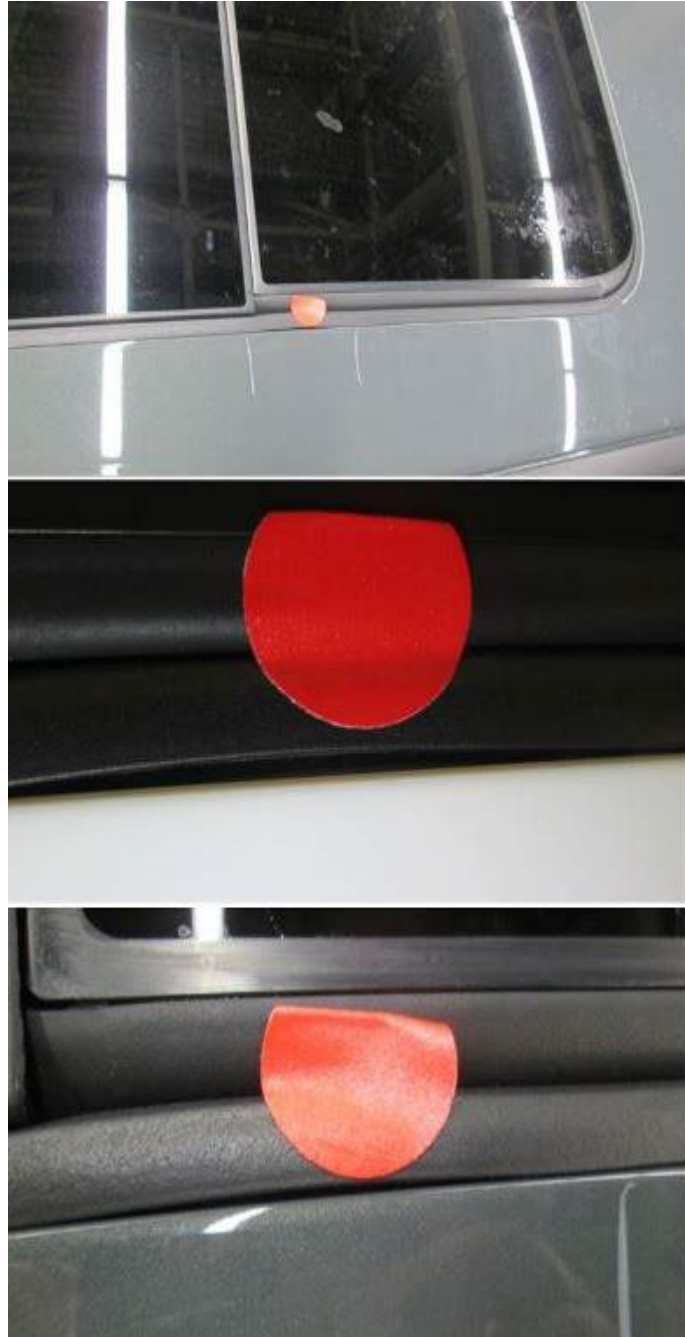
Inspect the entire perimeter of the roof opening seal for any possible detachment (Figure 4).

*Figure 4. Detached and malformed roof opening seal.*

If after inspecting the roof opening seal any detachment, malformation or damage is discovered, replace the sunroof opening seal. Refer to ElsaPro for inspection and repair procedures as well as the claiming labor operations and SRTs. Refer to TSB 2063187 for specific inspection and repair guidance.

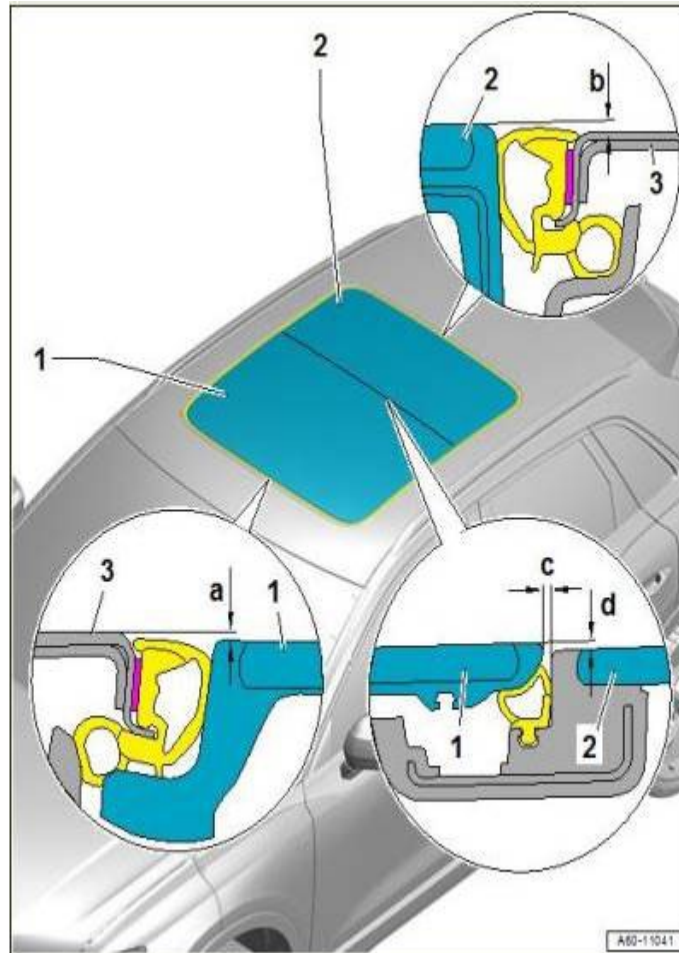
Check all adjustment axes of the sunroof glass panels for poor adjustment (Figure 5).

*Figure 5. Front and rear glass panel adjustment.*

If after all dimensional measurements are made on the sunroof glass panels an issue is found make the necessary adjustments to the sunroof glass panels.

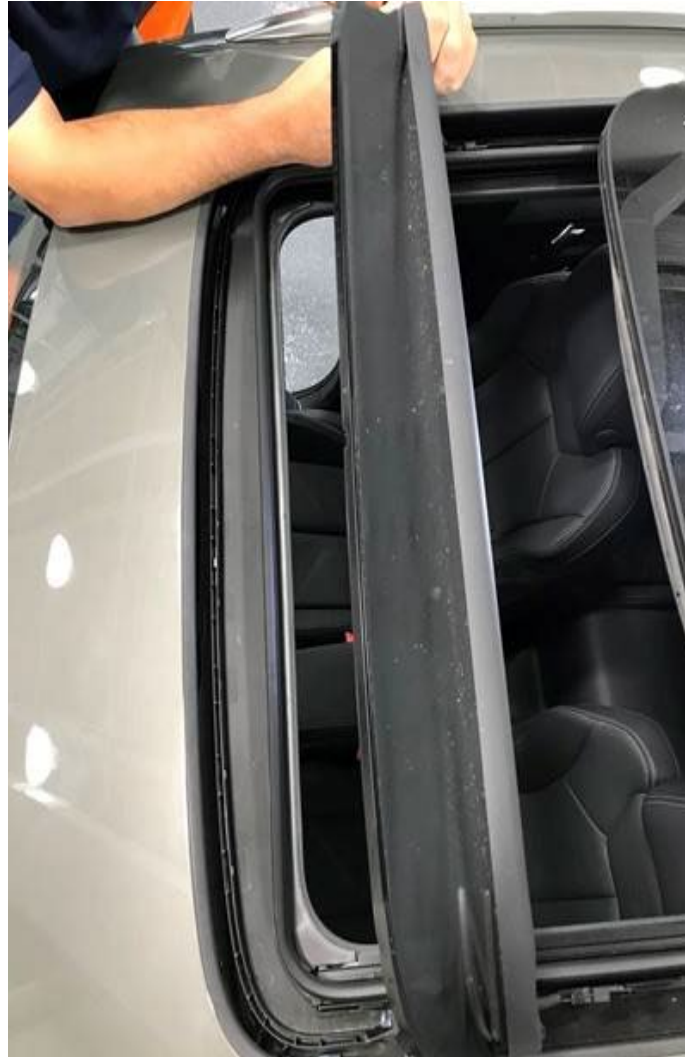
Any possible water drip may not appear until after a driving period when the water travels to the underside of the headliner area during the normal course of driving (Figures 6-8). This may occur due to a slow migration of water along the wind deflector hinge arms and potential water entry into the stowage area for the wind deflector. This stowage area does not provide water drainage away from the vehicle.

*Figure 6. Front sunroof opening with the drainage exposed.*

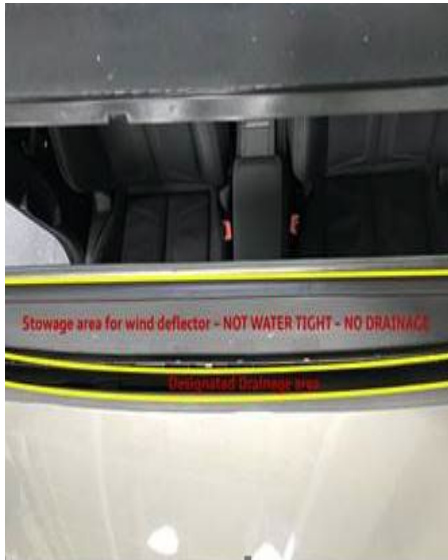
**Figure 7.** Areas of sunroof opening water elimination capabilities.

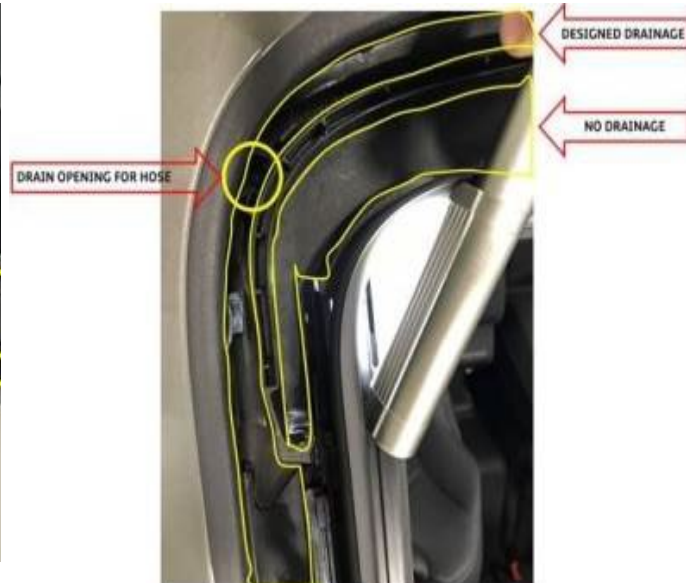
**Figure 8.** Sunroof water channeling diagram.

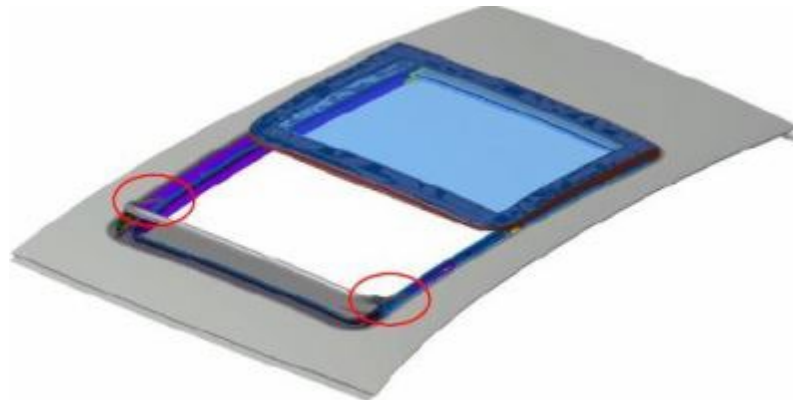
*Figure 9. Locating points for the sunroof wind deflector.*

5. Open the front sunroof panel completely and locate the mounting points for the sunroof wind deflector (Figure 9).

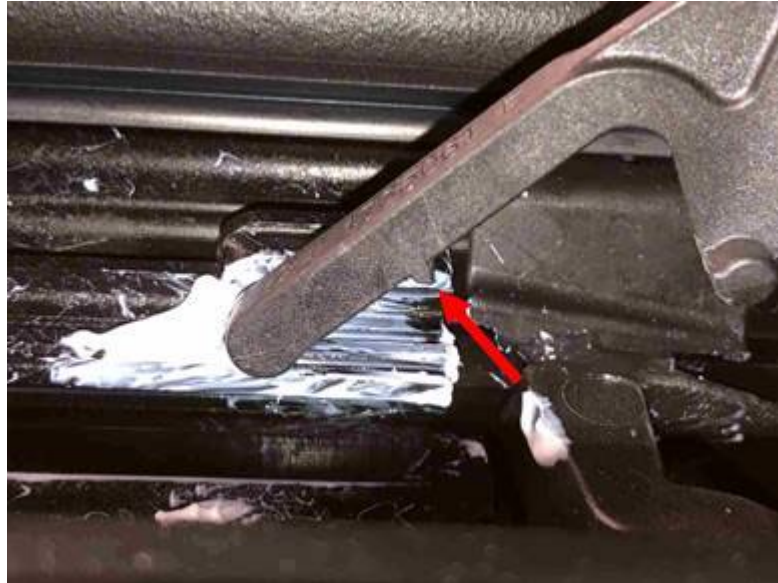
**Figure 10.** Tabs cast into the redesigned wind deflector.

6. There has been a design change to the wind deflector to enhance the water flow and drainage in the event the wind deflector gets wet. Inspect the area of the wind deflector shown (Figure 10). The redesigned wind deflector has small tabs cast into the deflector structure on both sides. If the wind deflector does not have these tabs replace the wind deflector. Make certain that the replacement wind deflector contains these tabs before installation. With the redesigned wind deflector installed, proceed as follows.

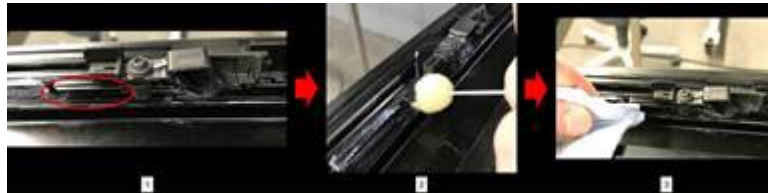
**Figure 11.** Area of sunroof frame to be cleaned.

7. Using a primer applicator D 009 500 25 (or equivalent) and D 009 401 04 all-purpose cleaner (or equivalent) thoroughly clean the area shown (Figure 11). It should be free of any lubricant or contaminants and completely dry.

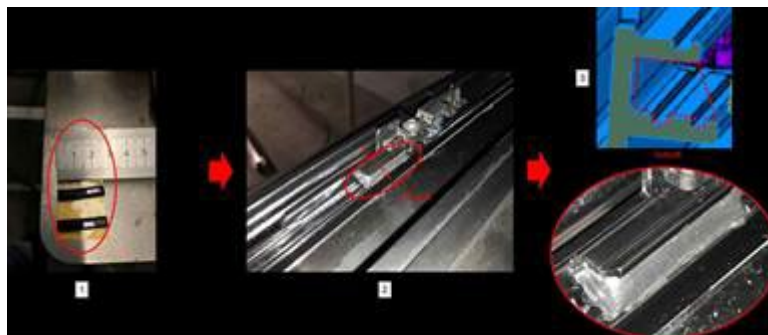
**Figure 12.** Preparation and application of butyl cord.

8. Cut two 25mm strips of AKL 450 005 05 Butyl adhesive/sealing cord. Firmly press each strip into the groove shown (Figure 12). Both channels shown in the cut away must be completely filled with the butyl cord.

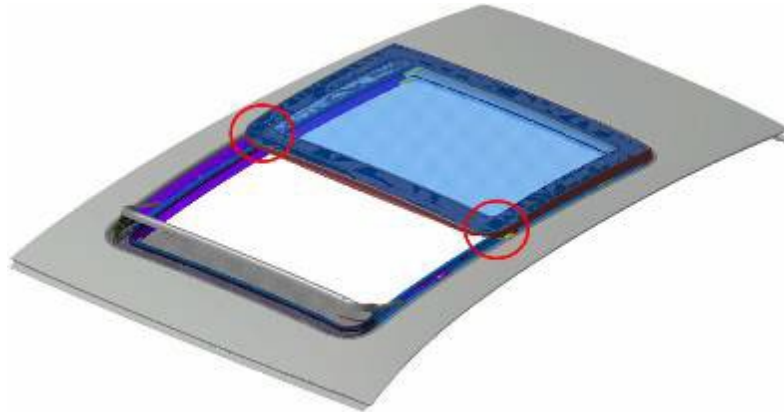
The purpose of this modification is to create a gap between the 'skirt' and the sunroof mechanism beside it, and as a result, prevent water from making contact with the sunroof mechanism and possibly breaching the water channels.

**Figure 13.** Area of sunroof glass panel to be modified.

9. Next, a modification will be made to the sunroof glass panel (Figure 13) by bonding two small pads to the front corners just inside the rubber 'skirt'.

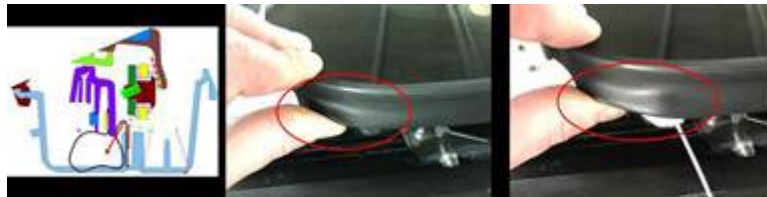
**Figure 15.** Area of glass panel 'skirt' where bonding agent is to be applied.

11. Apply D 355 205 A2 Bonding Agent using a primer applicator D 009 500 25 (or equivalent). Allow bonding agent to thoroughly dry (Figure 15).

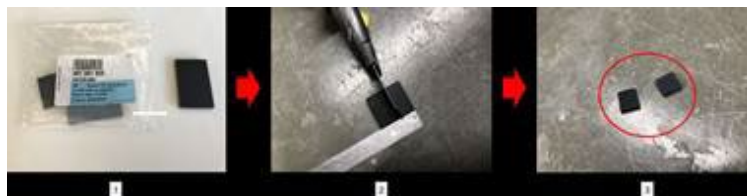
**Figure 16.** Preparing 2 – 10mm x 10mm pads of 251 201 525 packing.

12. Using 251 201 525 packing cut 2 x 10mm x 10mm pads (Figure 16).

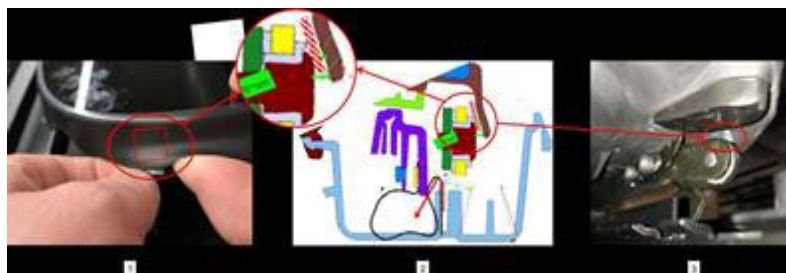
**Figure 17.** Positioning and application of the 10mm x 10mm pads.

13. Bond each pad to the front areas of the sunroof glass panel 'skirt' as shown in figure 15. A cut away drawing is included to illustrate the precise positioning of each pad from the inside (Figure 17).

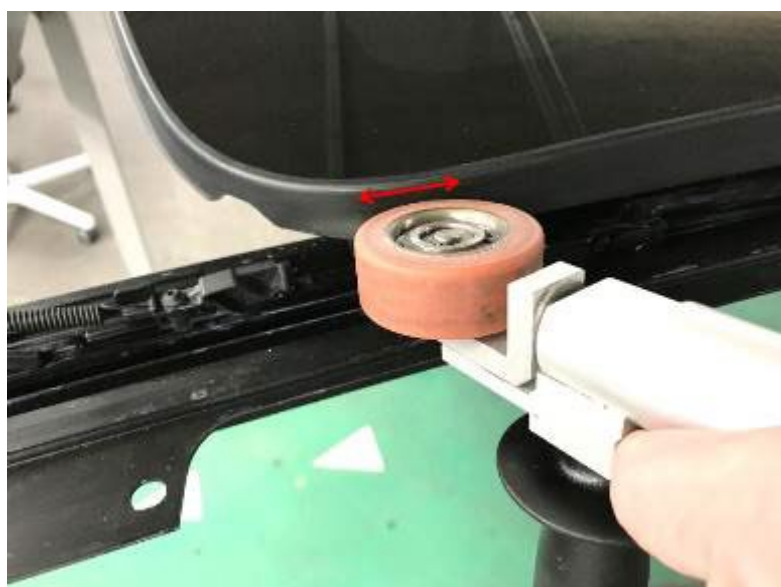
**Figure 18.** Applying pressure to bonded area with 3356 roller (or equivalent).

14. Using a 3356 roller tool (or equivalent), apply firm pressure (~50 Nm) to the newly adhered pads to enhance the strength of adhesion (Figure 18).
