SIB 52 14 23

THIRD SEAT ROW BACKREST BOWDEN CABLE CHANGE

2023-10-25

E-Series	Model Description	Affected Option Code
G07	X7 Sports Activity Vehicle	Vehicles with power third row seat SA4UB

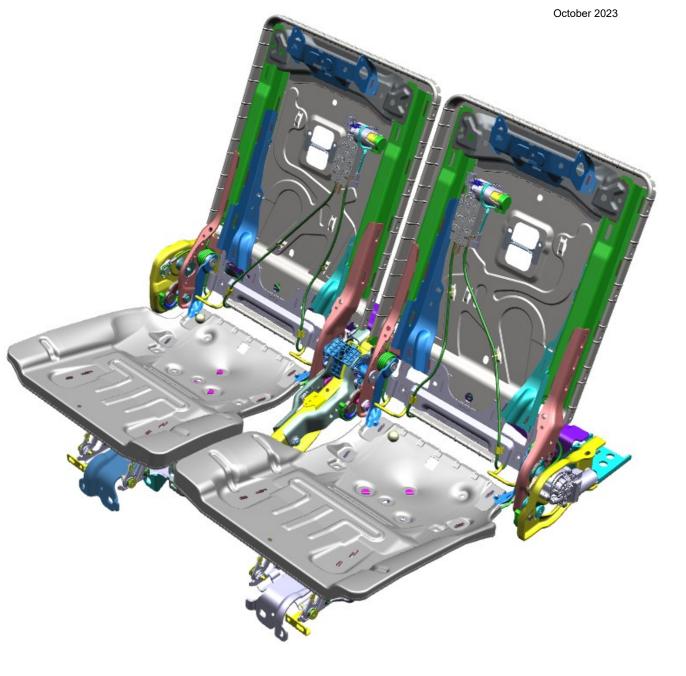
Place the seat structure in construction (upright) position. Like shown in the image.

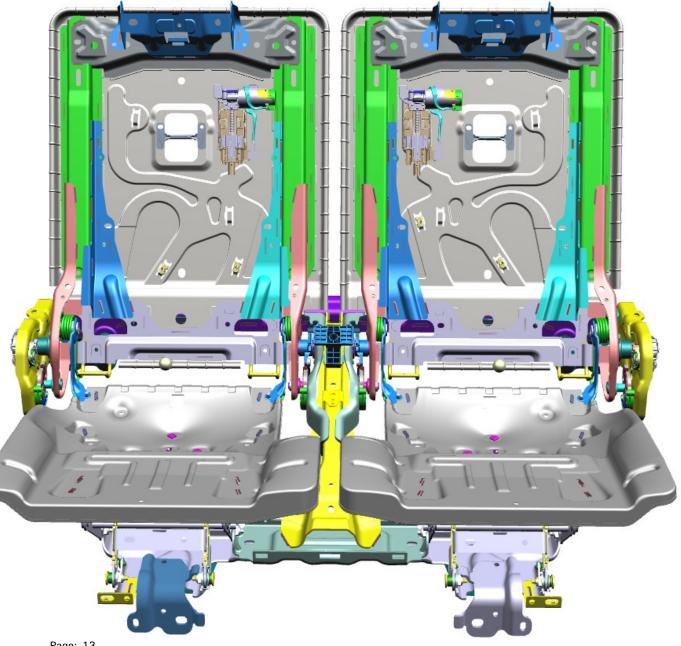
11. Seat Structure without Bowden cables

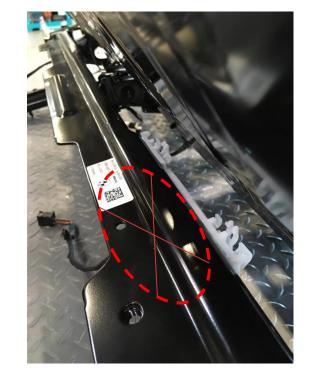
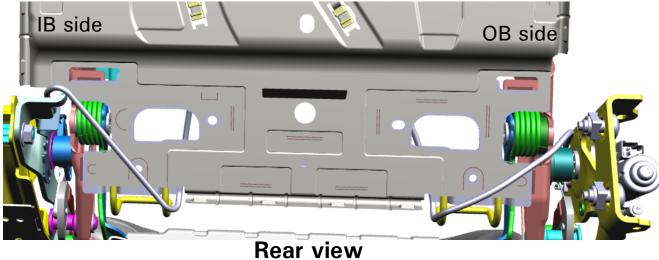
For **new Bowden cable assembly**; routing is not requiring the white fixation clip.

Bowden cable is going under the back panel and on the side of the isofix bracket, like it shows on the image.
