91-23-04 - MIB3 Recovery Solution

Release date: 10/18/2023

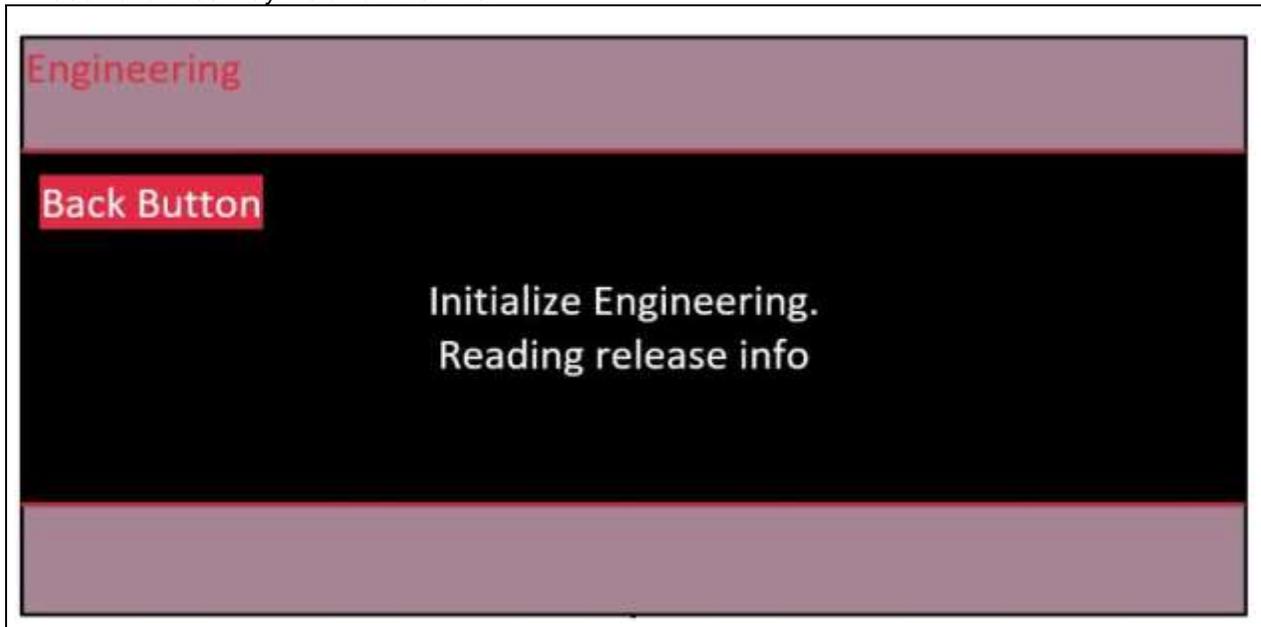
- Refer to Technical Bulletin 00-19-04 (2054866) Set up SD/USB Creator to Obtain Software Updates.
- Use USB part number **3G0.919.360.SE**.
- Switch the ignition to the OFF position.
- Connect the MTRMSP0702 battery maintainer/charger to the vehicle's battery.
- Insert the USB **3G0.919.360.SE** into the front USB-C connection.
- Switch the ignition to the ON position.
- Hold the "On/Off" button on the MIB display for a minimum of 10 seconds, then release.
- At this point, it may take up to 5 minutes to the system to start and initialize.
- If after 5 minutes, there is no response from the system, the above process may be repeated.
- If the recovery attempt is successful, the following screen may appear on the MIB display and additional files may install at this time.

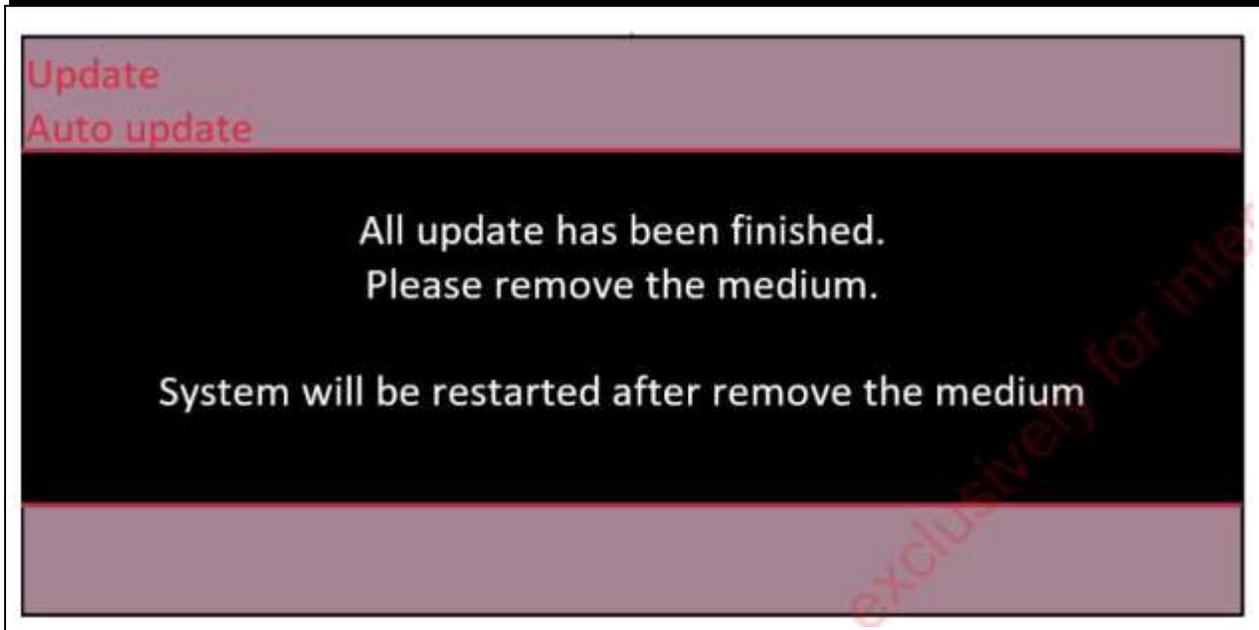
- Lastly, the following screen will appear on the MIB display indicating the process is complete.

- Remove the USB drive.
- The infotainment system should now boot up automatically.
- Once normal operation is restored, refer to any applicable technical bulletins regarding specific software level updates as applicable.
