Technical Service Bulletin

91 Navigation, Bluetooth, smartphone interface, and voice recognition is not available

91 23 33 2058007/2 October 12, 2023. Supersedes Technical Service Bulletin Group 91 number 19-18 dated December 9, 2019, for reasons listed below.

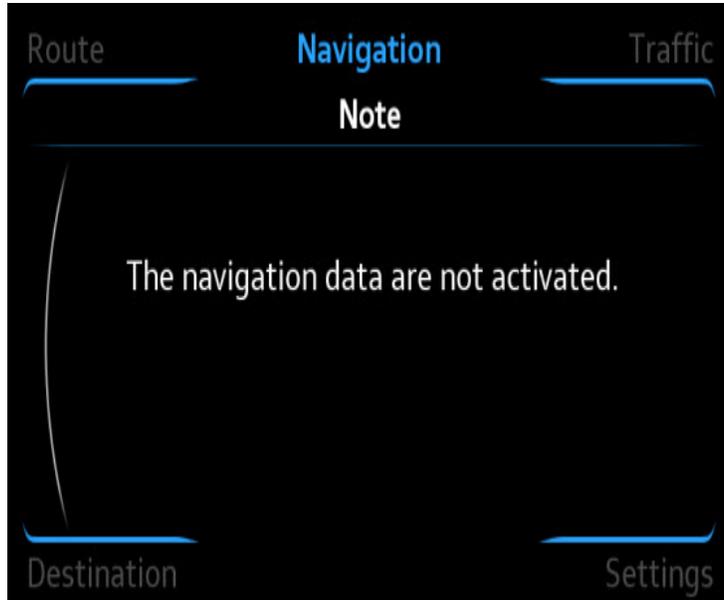
- Navigation is not activated (Figure 1 and Figure 2).
- Bluetooth is unavailable.
- Audi smartphone interface (ASI), including CarPlay or Android Auto, is not available.
- Voice recognition is unavailable in all cars except A3 Cabriolet (for A3 Cabriolet, see TSB f2038136: *91 Voice recognition is not available or not enabled*).

Figure 1. Navigation not activated message (Original MIB HMI).

1. There is a known issue with the activations keys stored in the MMI where they can become corrupt, thus the first step will be to delete the activation keys in the MMI. Delete the activations of the affected system using the ODIS test plan *DIAGNOSIS >> START DIAGNOSIS >> SPECIAL FUNCTIONS >> “SVM – Erase activations”* (Figure 5).

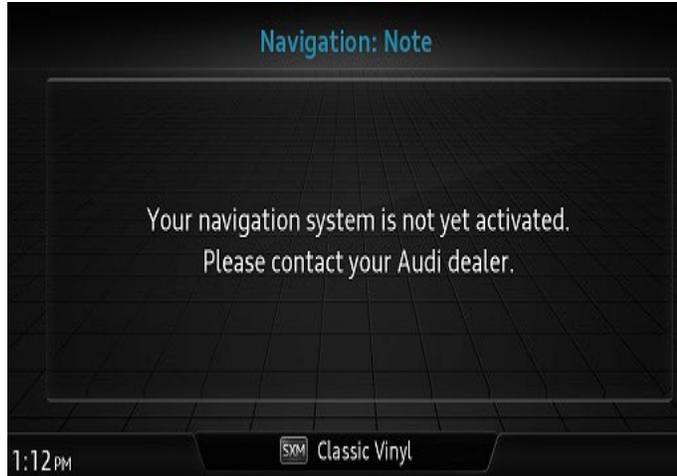
Figure 2. Navigation not activated message (New MIB2 HMI).

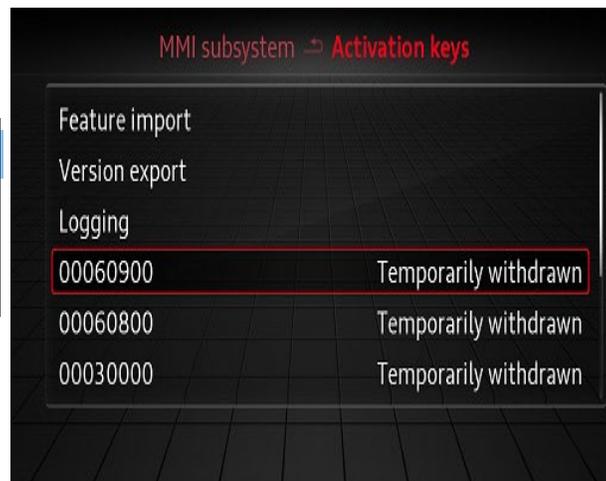
Temporarily withdrawn or Temp illegal = This indicates that the SVM activation test plan was not completed (Figure 4). This status is normal for all parts that have been swapped from a different vehicle. Perform the SVM Activations test plan as indicated below, under *Repair Procedure*.

Figure 4. Activation keys showing “Temporarily withdrawn”.

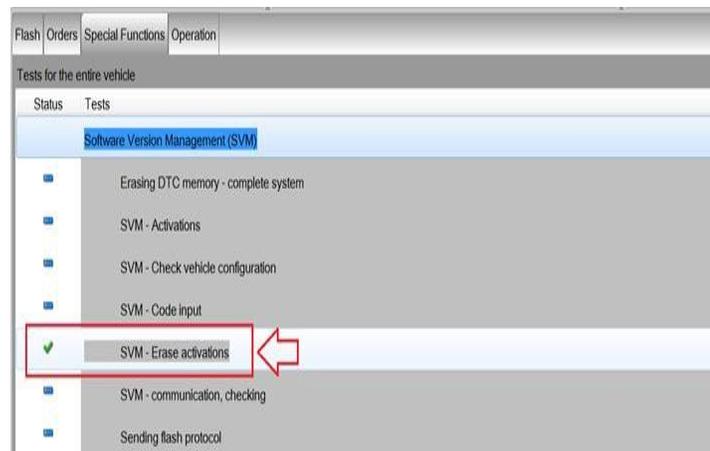
Figure 5. SVM – Erase activations.

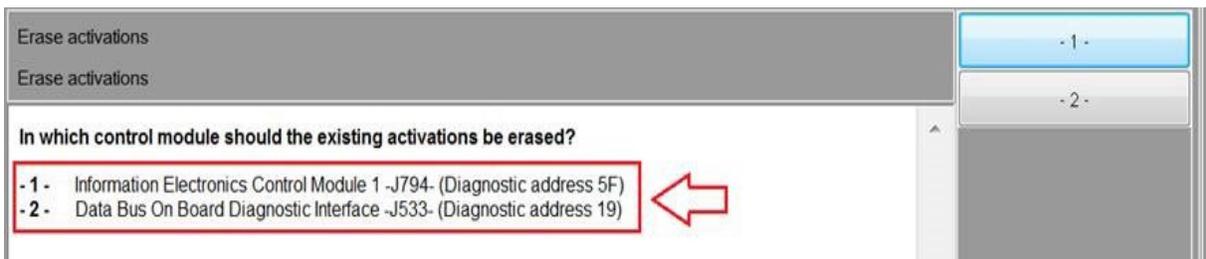
Figure 6. MMI (Information Electronics Control Module 1); Gateway (Data Bus On Board Diagnostic Interface).

- When prompted choose the appropriate system to delete activations based on the customer's concern:
 - For concerns with Navigation, Bluetooth, Audi smartphone interface, or voice recognition, select option -1- for the MMI (Information Electronics Control Module 1).
 - For concerns with Audi drive select, adaptive and regular cruise control, select option -2- for the Gateway (Data Bus On Board Diagnostic Interface) (Figure 6).

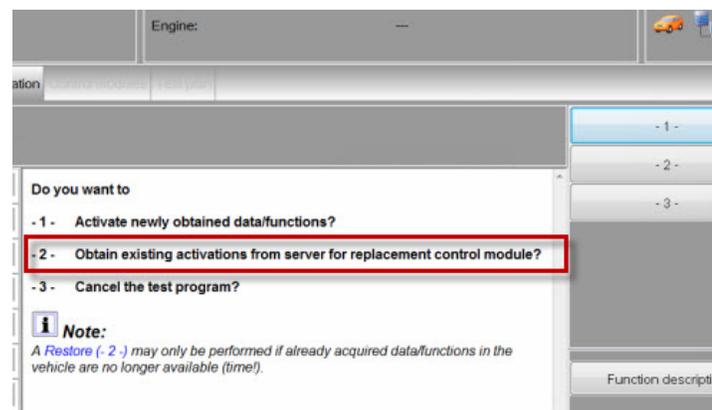
Figure 7. Obtain existing activations.

- When prompted, select “obtain existing activations” (Figure 7).
