# Technical Service Bulletin

## 91 No diagnostics communication to the telematics control module (ConBox); DTC U142100

91 23 36 2070942/2 October 26, 2023. Supersedes Technical Service Bulletin Group 91 number 23-15 dated July 19, 2023 for reasons listed below.

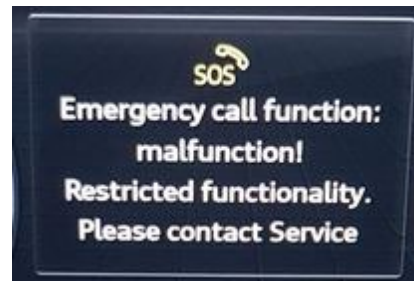
- An SOS Warning might be displayed in the instrument cluster (Figure 1).

Figure 1. Emergency call malfunction warning.

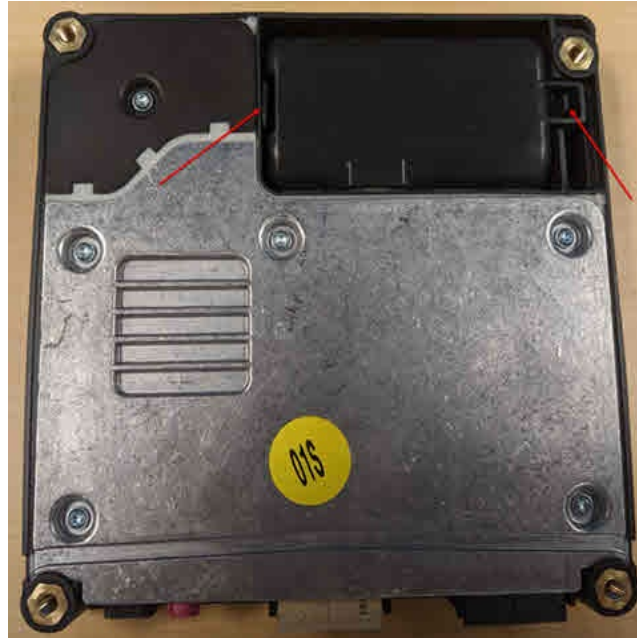
**Figure 2.** Backup battery compartment location.

2. Open the battery compartment of the control module for the emergency call module and communication unit, -J949- (address word 0075), and disconnect the backup battery (Figures 2 - 3).

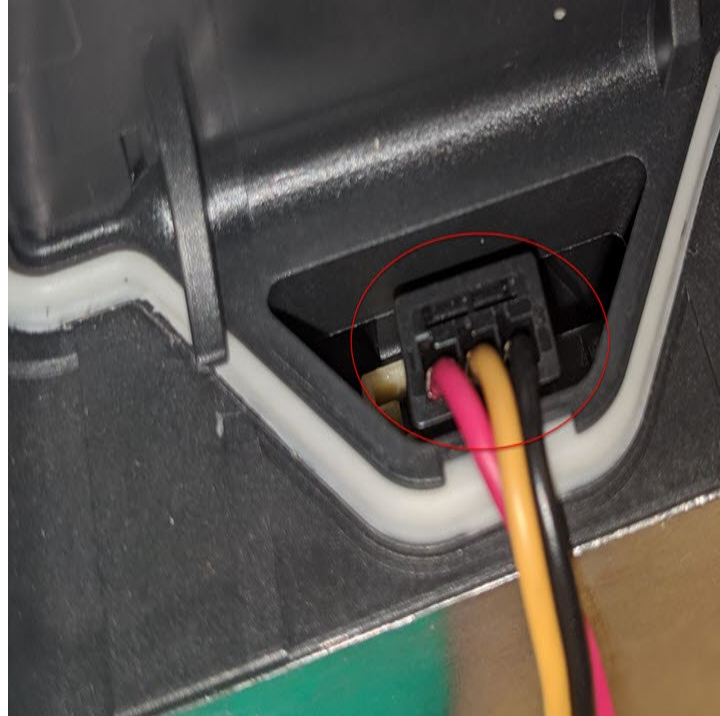
**Figure 3.** Backup battery connector (no release mechanism).

3. Wait approximately one minute, then reinstall the backup battery back into the control module for the emergency call module and communication unit, -J949- (address word 0075).
