Service Alert

Subject: DOOR LOCK CYLINDER IS MISSING THE COVER UNDERNEATH THE OUTER HANDLE	Service Alert No.: SA-069/23
	Last Issued : 10/24/2023

2023-2024 CX-50

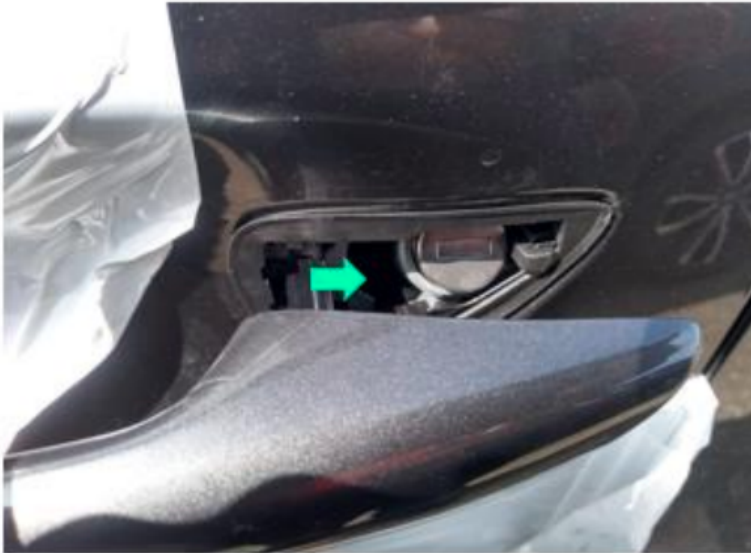
At PDI, it may be found that the outer door handle is missing the cover around the key cylinder.

NG

1. Check both sides of the vehicle.

2. Replace the missing cap(s).
