| Subject: WATER LEAK BETWEEN DOORS AT B-PILLAR | Service Alert No.: SA-068/23 |

2019-2024 Mazda3 (Japan and Mexico Built)

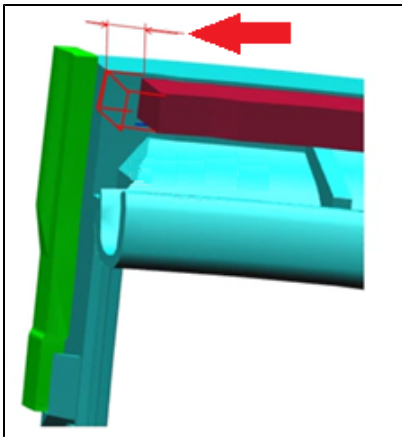
Some vehicles may have a water leak and/or a technician may find water inside the cabin or within a component. The source of the leak may be from between the doors at the B-pillar. To correct this concern, there was a mass production change (MPC) on January 14, 2021 to reduce the gap (as seen in the image below).

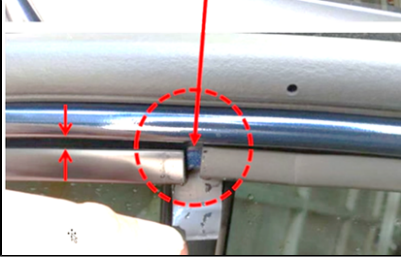
1. Verify the customer concern.
2. Is the water leak from the area shown in the image below?

YES - Replace both front and rear door seals and retest for a leak.
