DOOR BELTLINE MOLDING LOOSE OR FELL OFF

Service Alert No.: SA-067/23

Last Issued : 10/19/2023

2023 CX-50 produced before June 30, 2022

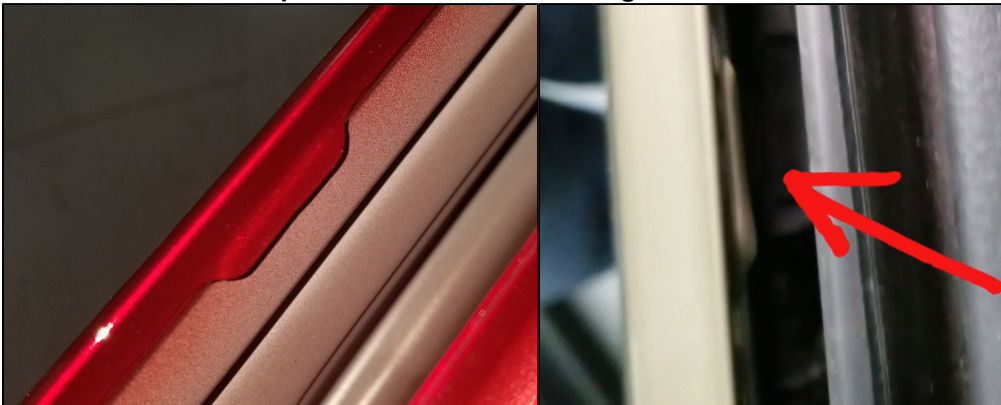
3. Use a hooked tool (e.g. a crochet hook) to straighten the bent tabs. The tabs may be bent in or out.

- If the tab is bent inward, the belt molding will not hold in place. When removed, the belt molding's internal clips can be damaged where it was properly held in place. **DO NOT** try to reuse it.
 - If the tab is bent outward, the belt molding's internal clips can be damaged during the installation and it will not hold in place. It must be replaced.
4. Replace all loose beltline moldings.
