REFERENCE NO: RF-23-10

SUBJECT: CX-90 Third-Row Seat Cargo Trim

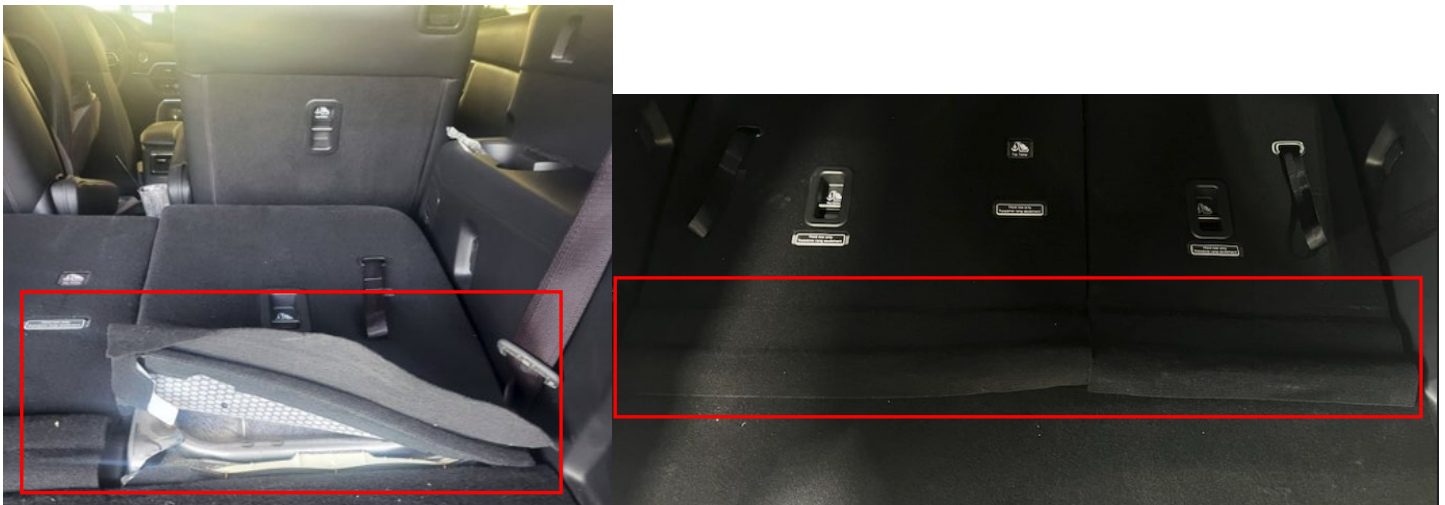
Some customers may report issues with third-row seats, loose or damaged trim, not folding down, binding when folding up, and other concerns.

NOTE: The trim is not a serviceable part and only available with the third-row seat assembly. For more information, please see Service Alert [SA-063/23](#) in MGSS for more information.
