Subject: CUSTOMER NOT COMFORTABLE WITH EMERGENCY LANE KEEPING AND/OR SMART BRAKE SUPPORT OPERATION	Bulletin No.: 15-002/23
	Last Issued : 10/09/2023

2024 CX-90 with VINS lower than JM2KK*****119478 (produced before June 28, 2023)

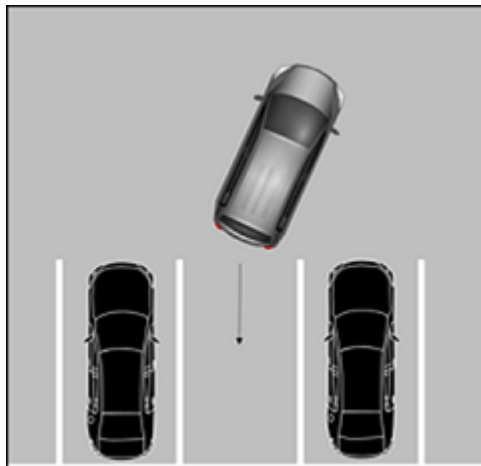
1. Sometimes the steering assist feeling by the Emergency Lane Keeping may be stronger than expected while driving at 60 km/h {37 mph} or faster.
2. The Smart Brake Support may operate unexpectedly when parking in reverse under certain conditions, mainly while driving at 2 km/h {1.2 mph} to 15 km/h {9.3 mph} on flat ground in reverse and vehicle(s) etc. are present around the parking space.

1. There was some room to refine the engineering for a better steering feel.
2. Too sensitive detection of vehicles or objects while in reverse and backing up.

To eliminate this concern, the control software of the Vehicle Control Module (VCM) has been modified. Customers having this concern should have their vehicle repaired using the following repair procedure.

1. Verify the customer concern.
2. Reprogram the VCM using the Mazda Diagnostic And Repair Software (MDARS). Refer to MDARS ECU Reprogramming Procedure.
