# Technical Service Bulletin

<b>Subject:</b>  CREAK OR SQUEAK NOISE FROM FRONT OF VEHICLE WHEN TRAVELING OVER A BUMP WHILE TURNING AT LOW-SPEED	<b>Bulletin No.:</b> 02-002/23
	<b>Last Issued :</b> 10/04/2023

2024 CX-90

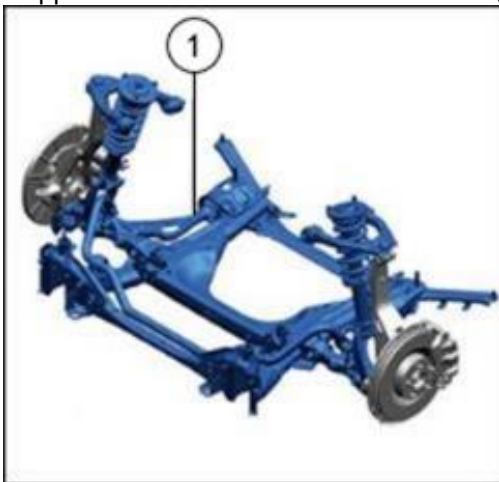
Some vehicles may exhibit a creaking or squeaking noise from the front of the vehicle when traveling over a bump while turning at low-speed. This is caused by a stick-slip phenomenon occurring between the rubber bushing and the stopper on the rear of the front lower arm (1). A mass production change is under study.
