Subject: WATER LEAK AROUND THE OVERHEAD CONSOLE	Bulletin No.: 09-034/23
	Last Issued : 10/09/2023

2024 CX-90 (with panorama sunroof) with VINS lower than JM3KK*****121941 (produced before July 12, 2023)

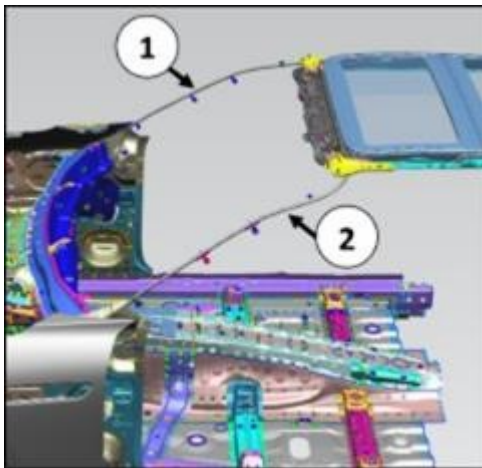
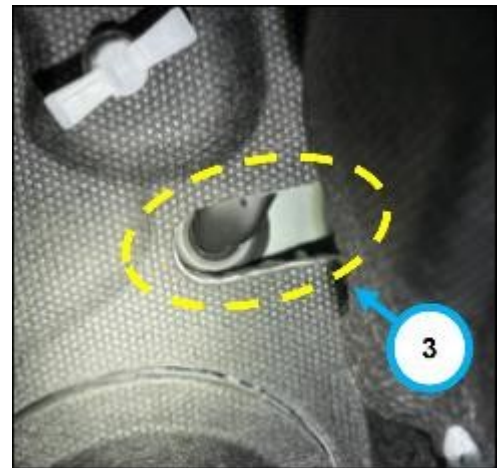
Some customers may complain about water leaks around the overhead console. This may be caused by the front drain hoses (1 and 2) for the panorama sunroof being trapped by the front dash panel insulator (3) and not being able to provide the correct water drainage.

To eliminate this concern, the front drain hoses placement has been changed so that the hose fits in the insulator notch. Customers having this concern should have their vehicle repaired using the following repair procedure.

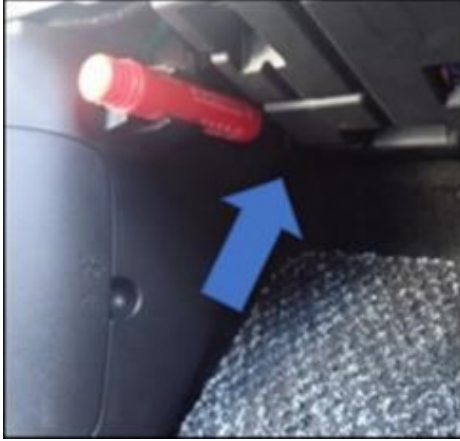
The location of the trapped point for left hand side.
(R.H.D. vehicle image)

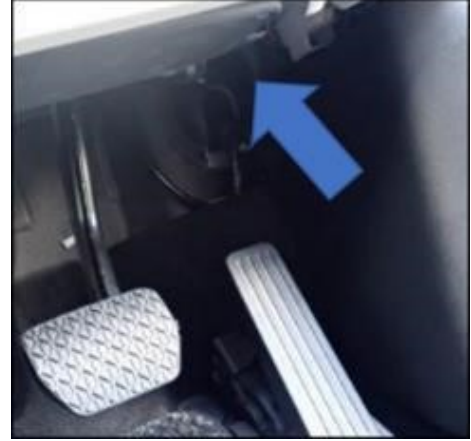
The location of the trapped point for right hand side.
(R.H.D. vehicle image)

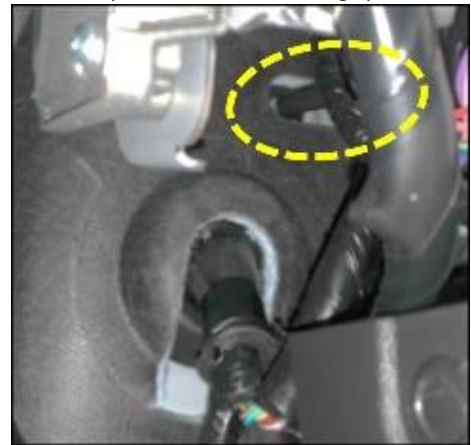
The zoomed up location of the trapped point for right hand side.
(R.H.D. vehicle image)
