# Service Alert

<b>Subject:</b>  <b>WATER LEAK FROM ROOF CAUSING ELECTRICAL AND MECHANICAL CONCERNS</b>	<b>Service Alert No.: SA-074/23</b>
	<b>Last Issued : 10/31/2023</b>

2020-2024 CX-30

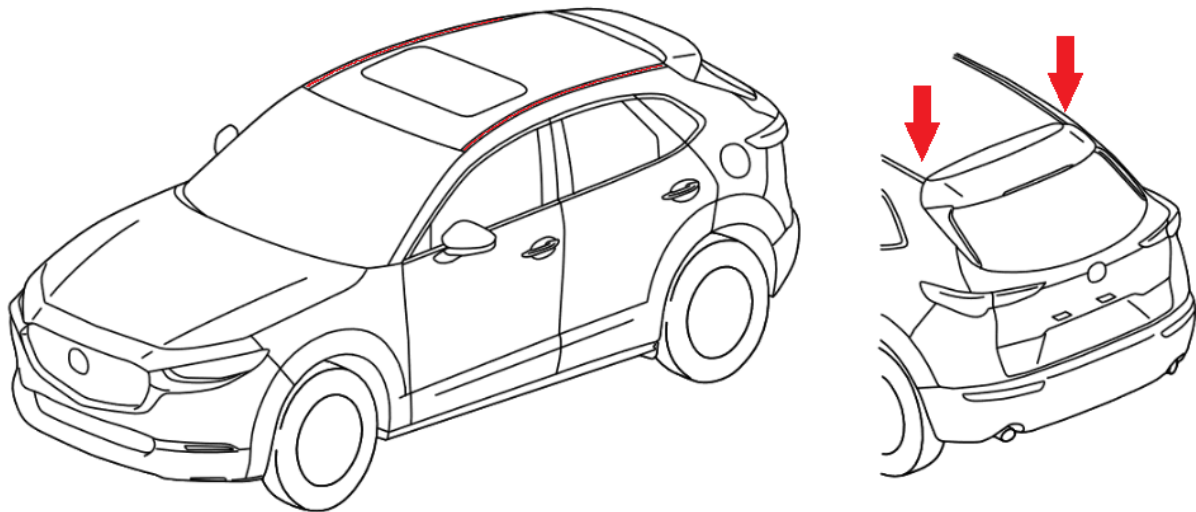
The source of the leak may be pinhole anywhere along the roof seams under the 2 trim strips (where the roof rails attach). Depending on the location of the leak, the headliner may or may not be visibly affected.

1. Document the following information on the RO:
  - Document all concerns caused by the leak (e.g. radio not working because Remote Tuner got wet).
  - Check for and document any stored DTCs.
  - Take photos of the area where the leak was found. These will be needed for the warranty claim or pre-authorization (if needed).
2. Check these locations on both sides of the vehicle for a small hole. If a leak is found at this location, sublet to a body shop for repairs.

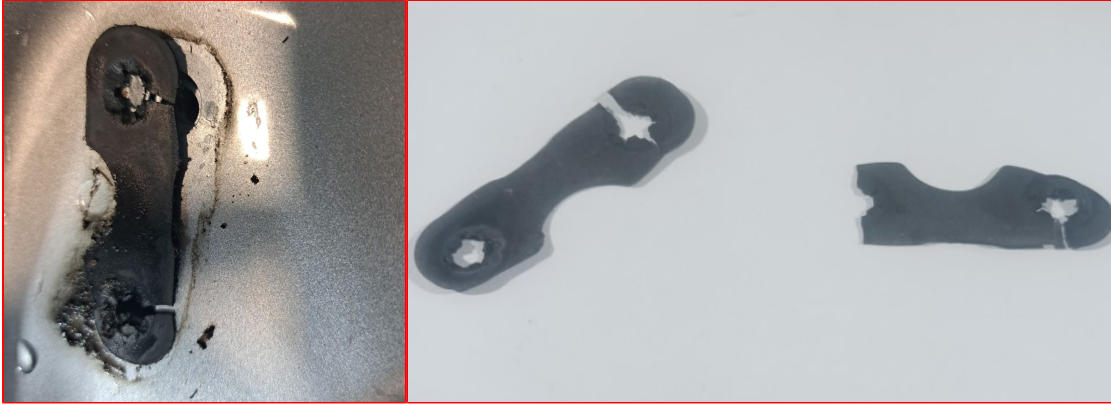
1. Remove the bracket using the **STAY DAMPER REMOVAL/INSTALLATION** procedure and remove the gasket. Do the liftgate strut bracket gaskets look the images below?

**YES** - Go to the next step.  
**NO** - Reassemble the struts.

2. Replace the gaskets and retest the vehicle for water leaks.
