Technical Service Bulletin

91 MIB3: MMI sidebar missing

91 23 40 2071928/1 October 30, 2023.

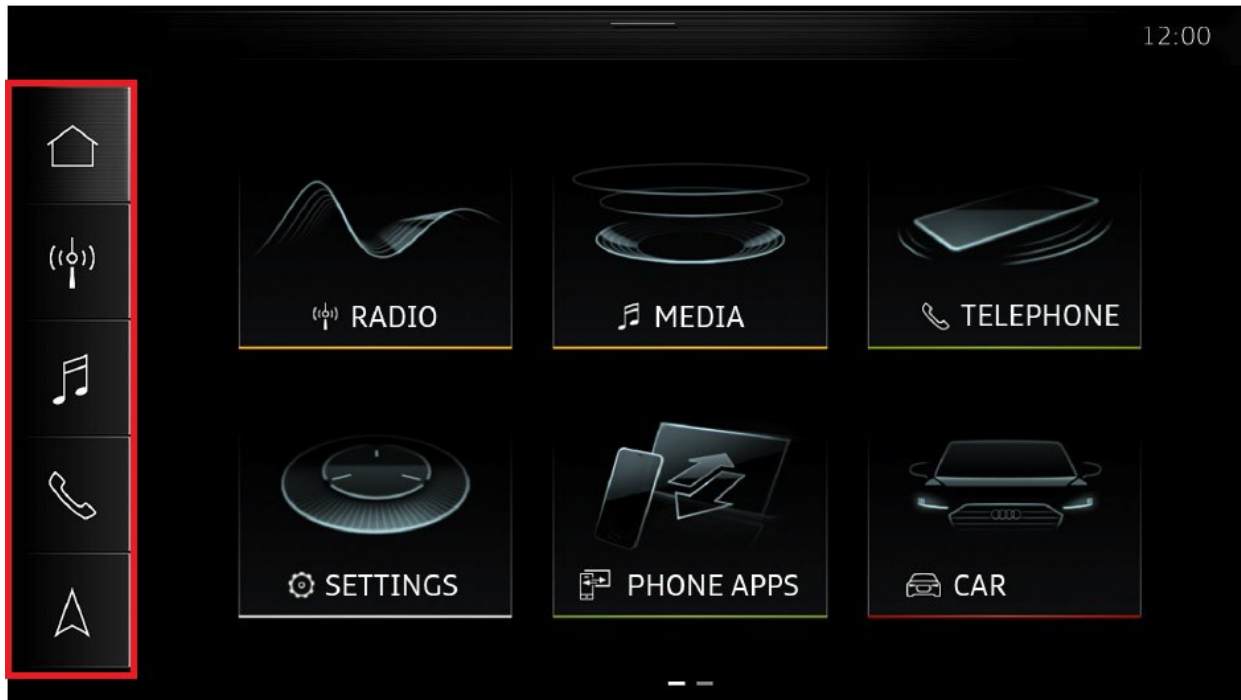
Figure 1: MMI sidebar

- The sidebar in the MMI (see *Figure 1*) is permanently missing.
- The MMI starts directly into the settings menu, making it impossible to use the infotainment system as intended.

A software related issue may cause the sidebar to disappear.

New information electronics software for MY23.

- MIB3 script on USB flash drive (see *Required Parts and Tools* or download the software from MirrorServer using the SD Creator Program).

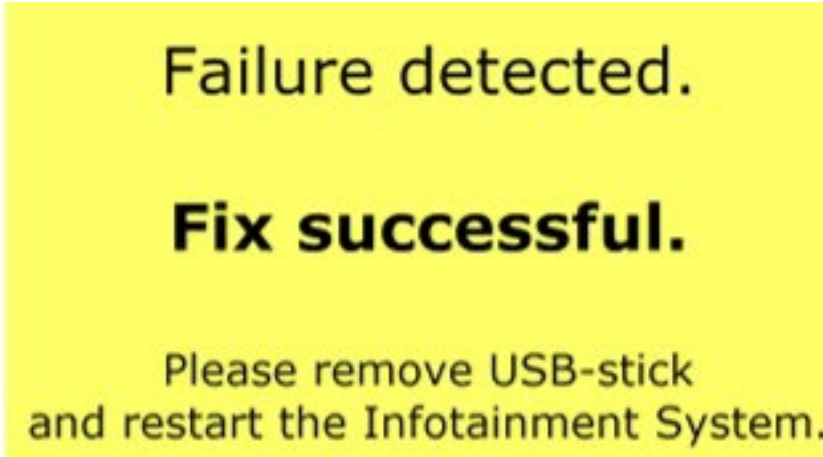
3. Insert the USB stick into the USB port on the affected vehicle
4. Wait until the following message is displayed:

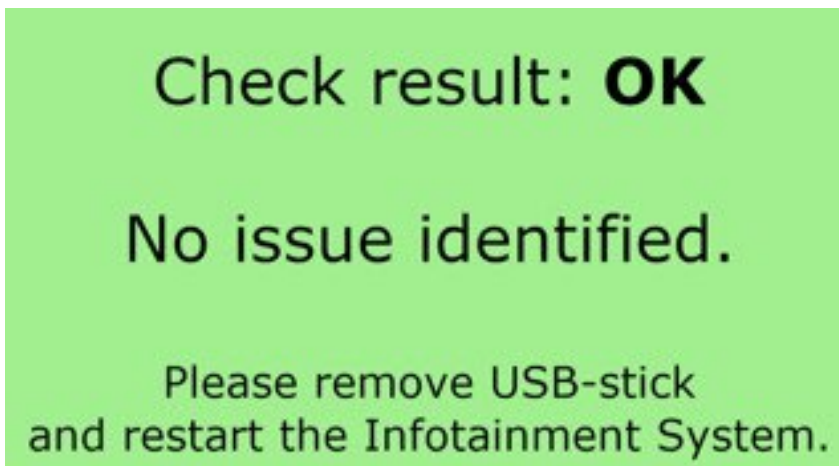
5. Turn off the ignition and lock the doors.
6. Wait approximately 5 minutes (ensure that the vehicle enters sleep mode)
7. Unlock the vehicle doors again
8. Remove the USB stick from the USB port
9. Turn on the ignition
10. Wait approximately 5 minutes (to ensure the MIB has started fully)
11. Re-insert the USB stick into the USB port on the affected vehicle
12. Check the following message is displayed to ensure that no software issues are detected:

NOTICE
<p>If the green message (step 12) already appears at step 4, the control unit for information electronics (J794) is not affected by the software issue described above. In this case, diagnosis of the problem is outside the scope of this TSB.</p>
