# Technical Service Bulletin

## 96 Button for rear dome light is stuck or inoperative

96 23 88 2064285/2 October 23, 2023. Supersedes Technical Service Bulletin Group 96 number 21-73 dated August 18, 2021 for reasons listed below.

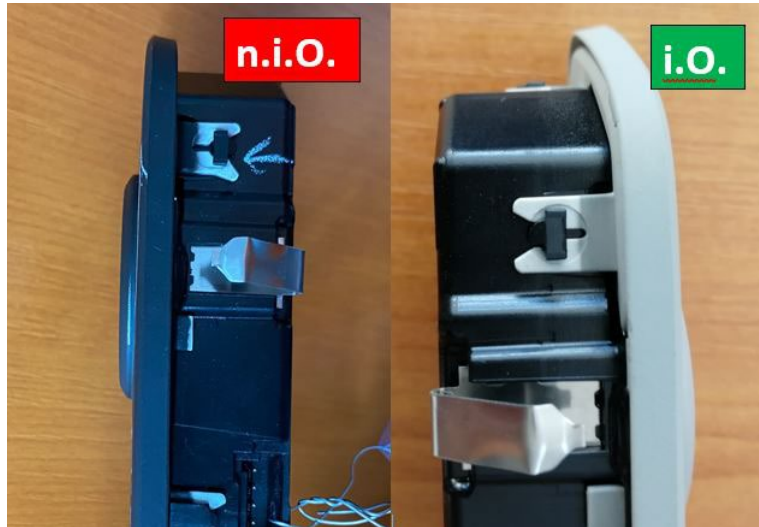
Increased pressure on the button which operates the light can result in the trim of the button separating from the switch base. As a result the button may become stuck or no longer function.

**Figure 1.** Left photo shows trim dislodged from base. Right photo shows trim properly seated to switch base.

1. If a customer concern is present and the switch is found to be inoperative, first check that the switch trim is properly seated to the switch base.
2. Remove the rear dome light switch from the headliner and check whether the trim is properly clipped (Figure 1).

3. If the trim has separated from the base, reassemble the switch and install back into the vehicle. Parts replacement does not solve this issue. Claims for replaced parts will be subject to review.
